<b>Subject:</b>  MIL ILLUMINATED - P0455 SET	<b>Bulletin No:</b> 01-040/09
	<b>Last Issued:</b> 10/05/2009

2007 CX-7 vehicles with VINs from JM3 ER\*\*\*\* \*\* 100057 to 128616

2006-2007 MX-5 vehicles with VINs from JM1 NC\*\*\*\* \*\* 111723 to 125568

2006-2007 RX-8 vehicles with VINs from JM1 FE\*\*\*\* \*\* 200012 to 208462

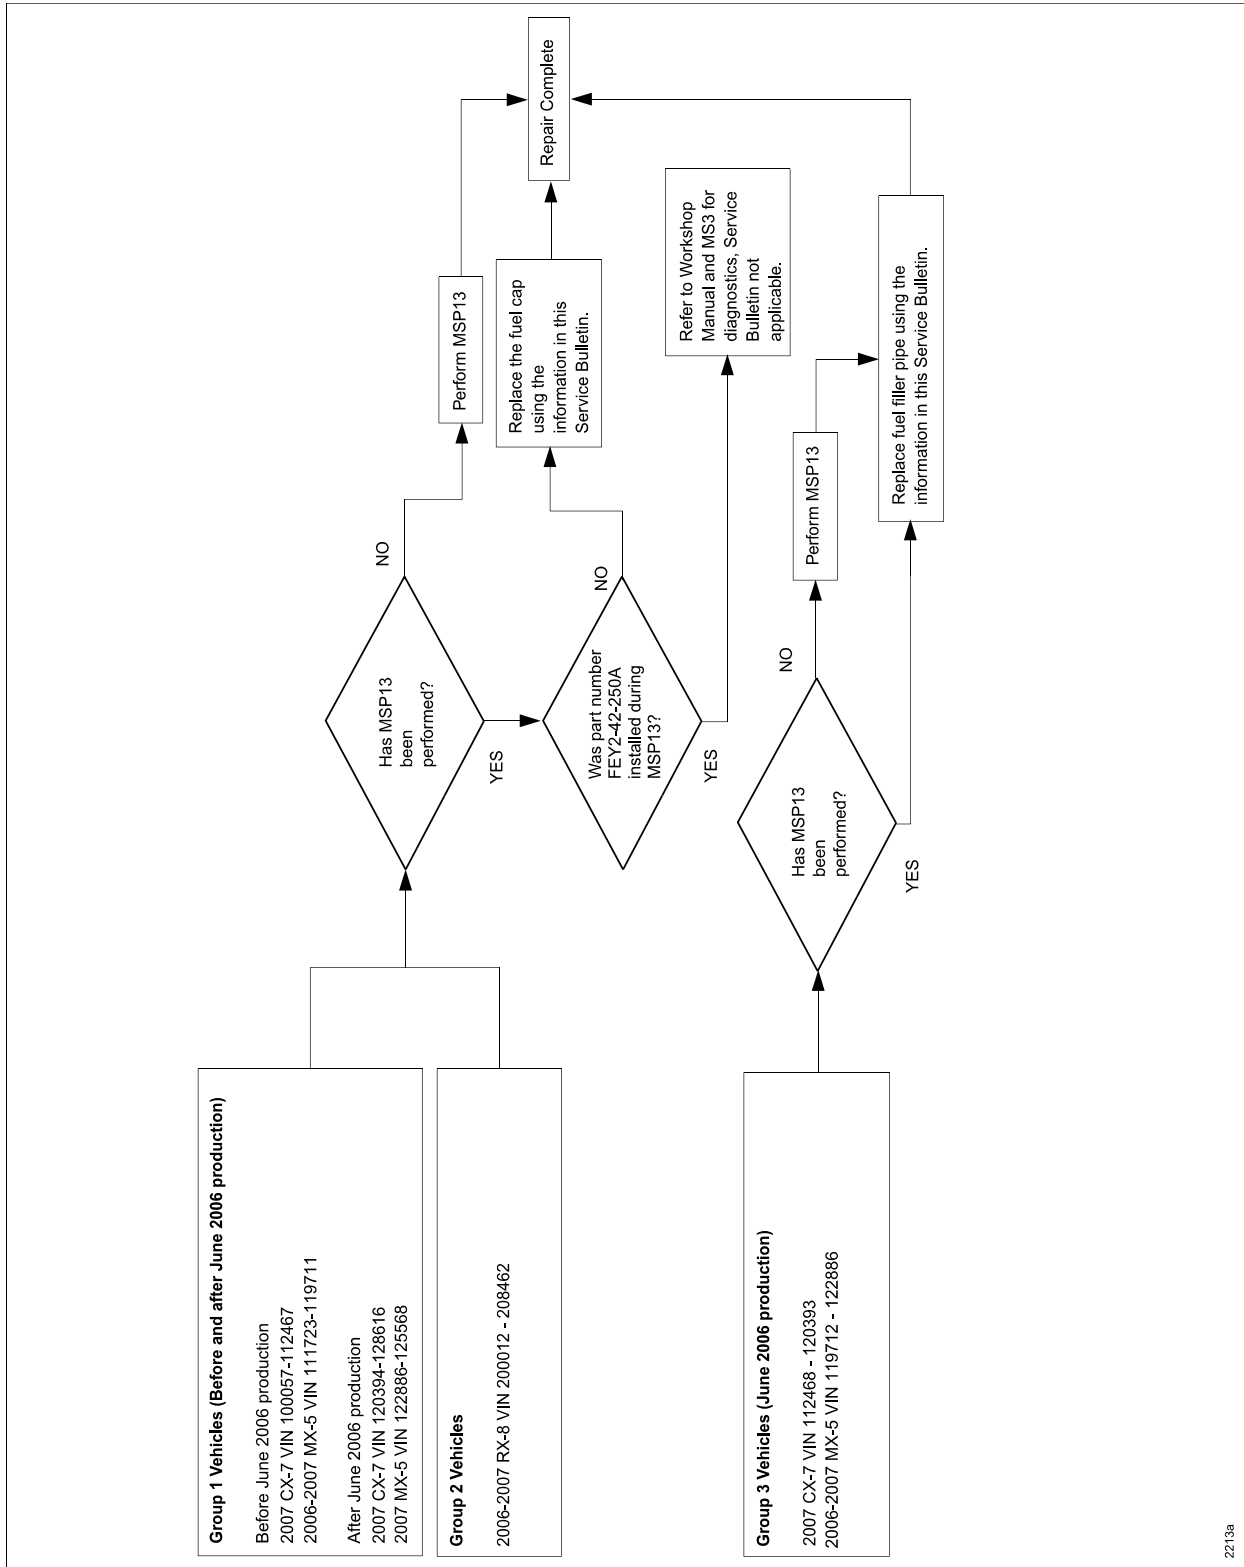
Some vehicles may experience MIL illumination with DTC P0455 stored in memory due to improperly tightened fuel filler cap.

Some fuel filler pipes may be out of specification and in some cases, may not allow the fuel filler cap to be fully tightened. As a mass-production change, the fuel filler pipe and the fuel cap have been modified. Depending on the vehicle VIN range, either the fuel filler pipe and/or fuel cap may need to be replaced.

1. Verify customer concern.
2. Perform MSP13 and/or replace the fuel cap or fuel filler pipe according to the chart. For fuel filler pipe, refer to MS3 online instructions or Workshop Manual section 01-14 FUEL TANK REMOVAL / INSTALLATION.
3. Verify repair.
