<b>Subject:</b>  <b>FRONT BRAKE CREAKING AT LOW SPEEDS</b>	<b>Bulletin No:</b> 04-001/09
	<b>Last Issued:</b> 2/12/2009

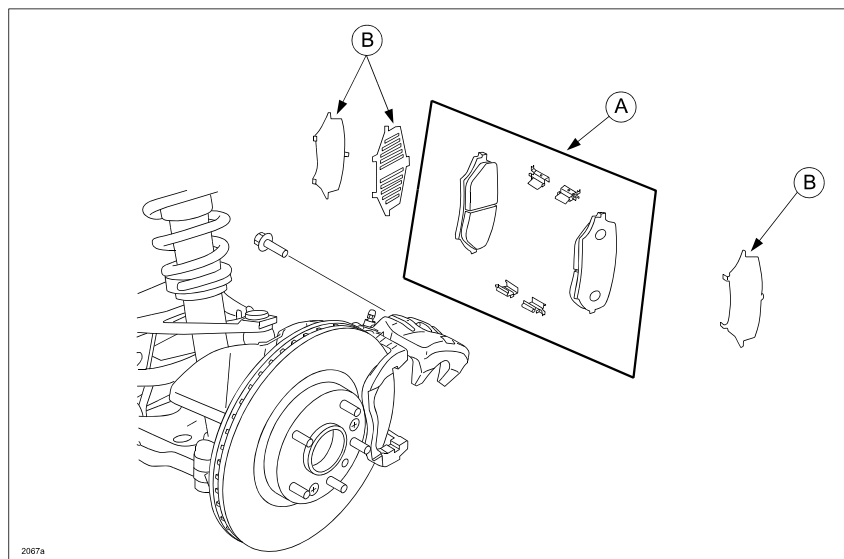
Some vehicles may exhibit a creaking noise when the brake pedal is gently depressed while driving at low speeds. The creaking noise is due to resonance of the front brake pad guide plate. The thickness of the guide plates have been increased to correct this concern.

1. Verify customer concern.
2. Replace front caliper pad sub set with modified parts (A). Refer to MS3 online service information or Workshop Manual section 04-11 DISC PAD (FRONT) REPLACEMENT. Reuse the existing attachment plates (shims) (B) when installing the modified parts.
