Subject: RETRACTABLE TYPE KEYLESS ENTRY REMOTE TRANSMITTER DOES NOT WORK	Bulletin No: 09-003/10
	Last Issued: 04/21/2010

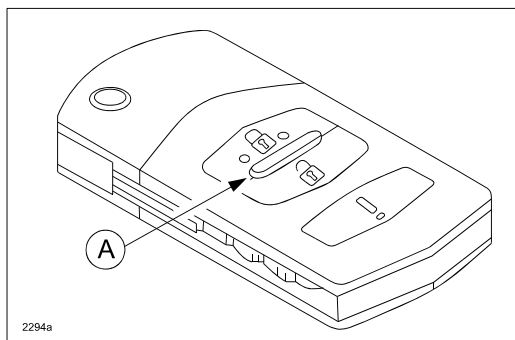
1. Verify customer concern.
2. Press the "UNLOCK" button on the transmitter and check if the LED (A) on the transmitter illuminates or not.
 - If it does illuminate, this repair information does not apply. Refer to MS3 online instructions or Workshop Manual section 09-14 SYMPTOM TROUBLESHOOTING CHART [KEYLESS ENTRY SYSTEM].
 - If it does not illuminate, go to the next step.

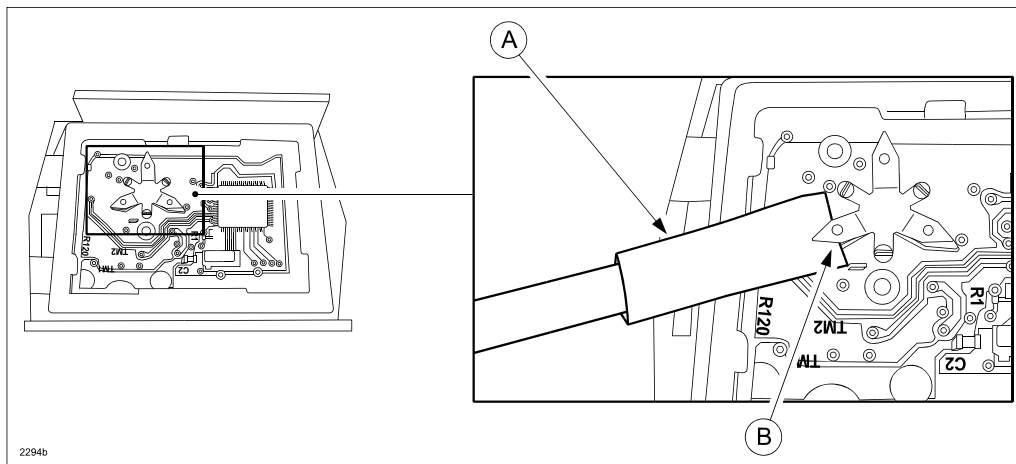
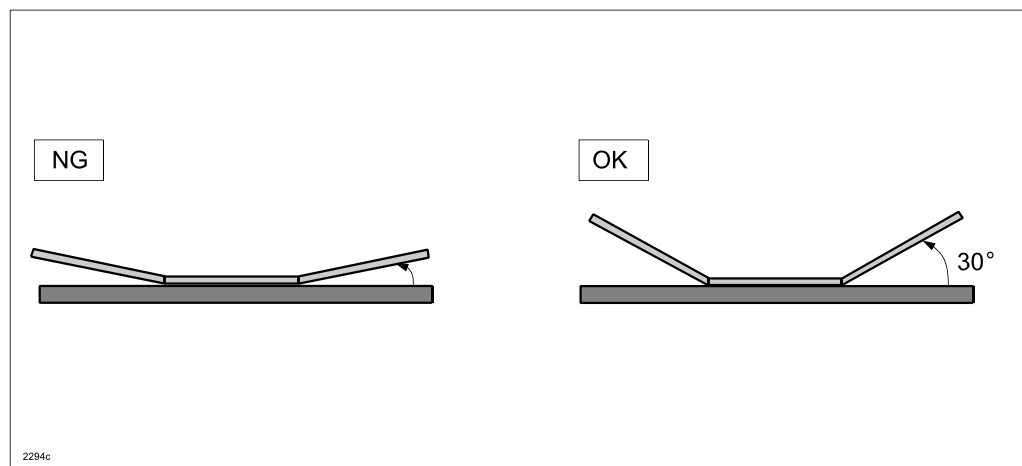
Some customers may complain that the LED light on the retractable type keyless entry remote transmitter does not illuminate and the transmitter does not work at all. This is caused by poor contact between the transmitter and the battery. The production procedure has now been improved to correct this problem.

4. Using a Digital Volt meter, test the transmitter battery voltage.
 - If the transmitter battery voltage is less than 2.7 V, get a new battery, then go to next step.
 - If the transmitter battery voltage is 2.7 V or more, go to the next step.
5. Wrap the tip of a small flat screwdriver with vinyl tape (A), and use it to lift up the 3 battery terminals (B) on the circuit board approximately 30 degrees to the plane.

NOTE: In order to achieve enough pretension, it is necessary to bend the terminals approximately 30 degrees.

CAUTION: Be careful not to damage any element and/or printed pattern on the circuit board. Also, avoid bending the terminals too much as this may break it.

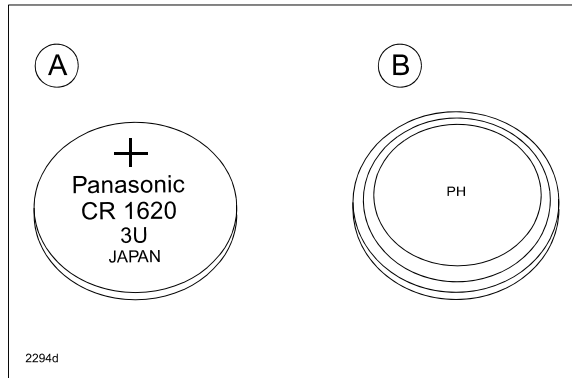
A: Upper side (+)

B: Bottom side (-)

6. Reinstall the battery in the transmitter. Refer to MS3 online instructions or Workshop Manual section 09-14 TRANSMITTER BATTERY REPLACEMENT [WITH KEYLESS ENTRY SYSTEM].

NOTE: Before installation, wipe both sides of the battery with a clean, dry cloth to clean the terminals.
