<b>Subject:</b>  MIL ON / P2004 SETS AFTER STARTING ENGINE	<b>Bulletin No:</b> 01-055/06
	<b>Last Issued:</b> 12/20/2006

2004-2005 Miata

2004-2005 MAZDASPEED MX-5

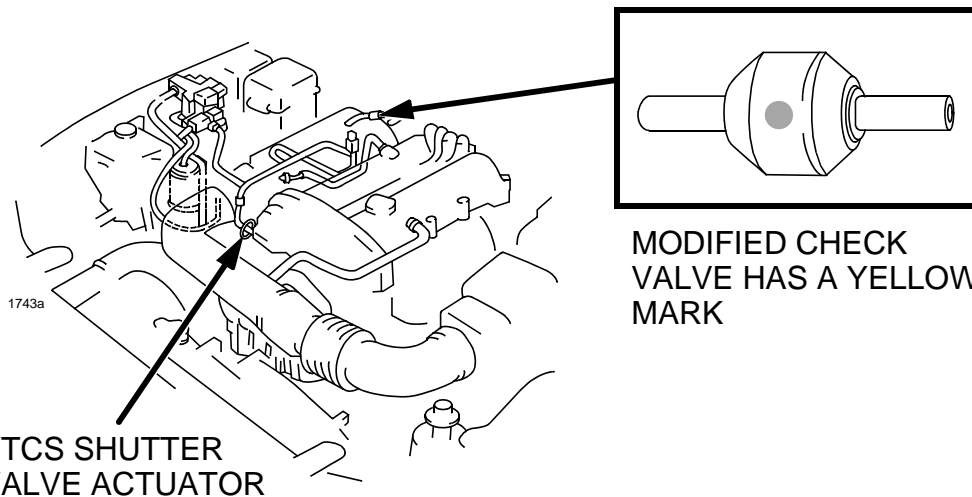
On some vehicles, after sitting overnight and started, the MIL comes on and DTC P2004 sets into PCM memory. This occurs because vacuum (momentarily) does not flow into the Variable Tumble Control System (VTCS) shutter valve actuator. The contact surface between the valve and the valve body inside the check valve is smooth causing the valve to momentarily stick before more vacuum applies, opening the valve.

- Modified check valve can be identified by Yellow marking on the valve body.

1. Verify customer concern.
2. Replace check valve with a modified part.

3. Verify repair.
