Subject: GRINDING OR UNUSUAL NOISE FROM MANUAL TRANSMISSION WHEN DRIVING IN 2ND AND/OR 3RD GEAR	Bulletin No: 05-007/16
	Last Issued: 12/07/2016

2016-2017 MX-5 vehicles with VINs lower than JM1ND****H*121392 (produced before September 6, 2016)

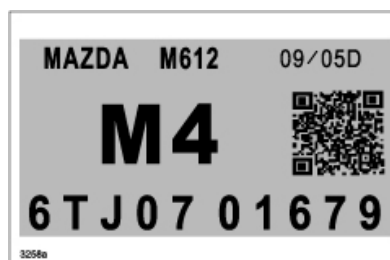
NOTE: Transmissions with the serial No. "6TJ0701679" or higher are modified.
