Subject: GAP APPEARS IN HARD PLASTIC DOOR TRIM PANELS	Bulletin No: 09-006/07
	Last Issued: 2/15/2007

2006-2007 MX-5 with VINs JM1 NC**** ** 115173 to 127945 (built from March 1, 2006 to September 7, 2006)

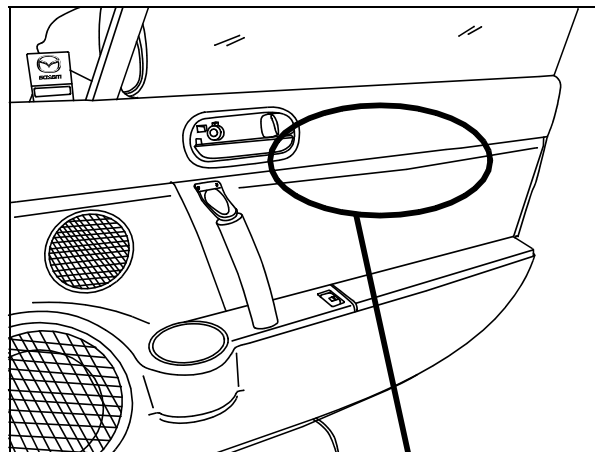
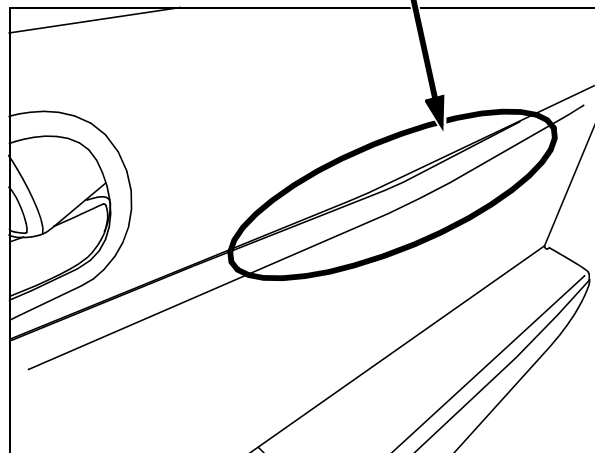
1717a

On some vehicles with plastic door trim (panels) only, a gap may appear in the location as indicated in illustration below.

GAP IS NOTICEABLE BETWEEN UPPER
AND LOWER PORTIONS OF DOOR PANEL

During hot ambient temperatures, the foam pad attached to the door lock cable pushes the door panel out, causing a gap. As a mass-production change, the shape of the pad attached to the door lock cable has been modified.

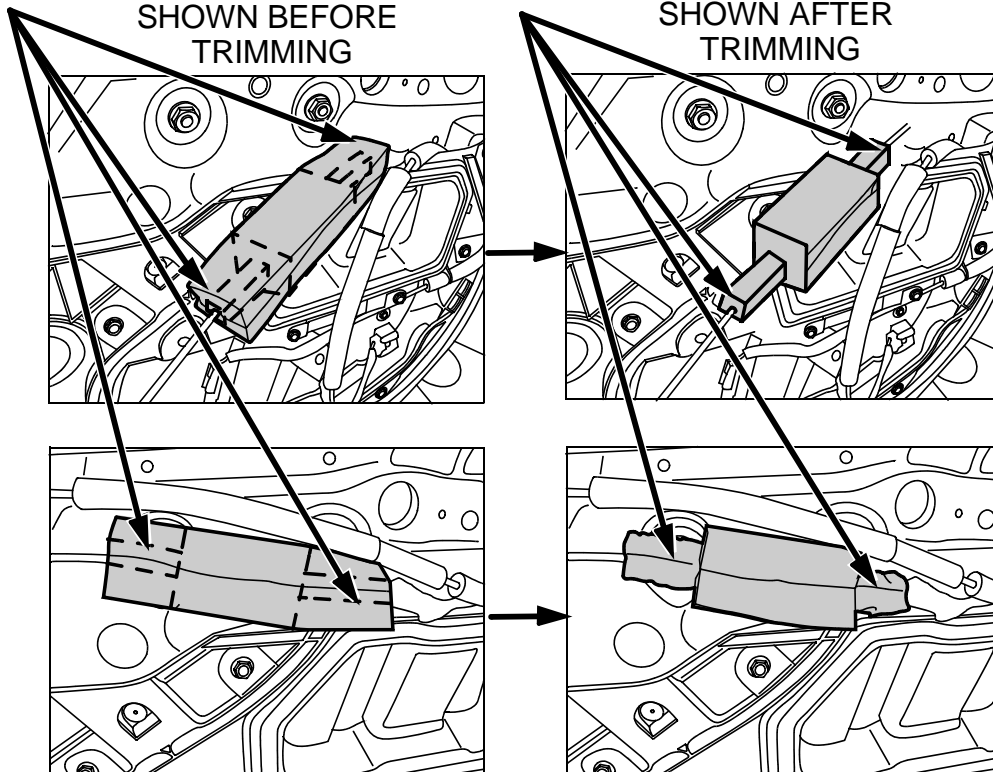
TRIM BOTH
ENDS OF
FOAM
INSULATION

FOAM PAD
SHOWN BEFORE
TRIMMING

LEAVE APPROX.
0.2" (5mm) OF
FOAM ON THE
CABLE

FOAM PAD
SHOWN AFTER
TRIMMING

3. Trim the existing door lock cable foam pad as illustrated below.

- Trim foam approximately 1-1/2" (38mm) x 1/2" (13mm) inwards from each end until the finished product resembles the image below.
