Subject: MULTI-MODEL - WIPER RUBBER INSERT REPLACEMENT	Bulletin No: 09-009/10
	Last Issued: 02/12/2010

- 2006-2010 MX-5
- 2004-2010 RX-8
- 2004-2010 MAZDA3
- 2006-2010 MAZDA5
- 2003-2010 MAZDA6
- 2007-2010 CX-7
- 2007-2010 CX-9

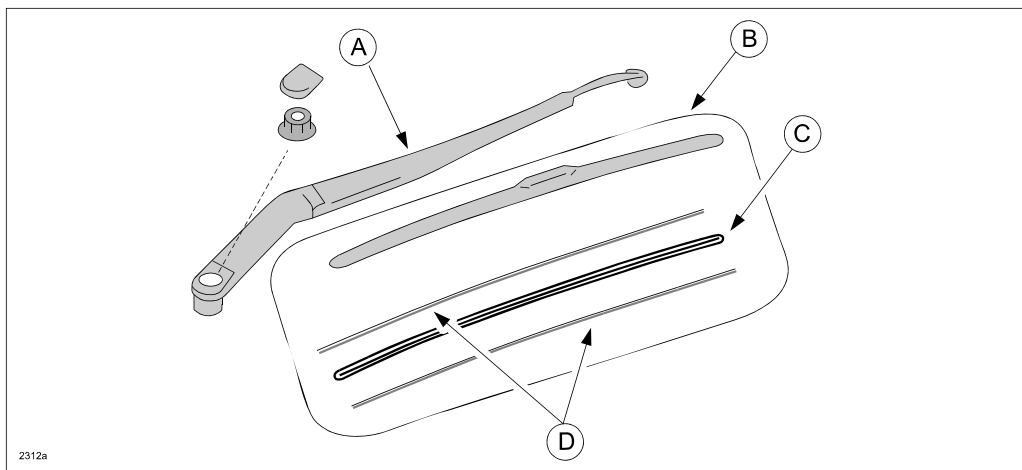
Poor window wiping issues (streaky surface, buzzing noise, etc.) usually occur due to contamination, damage or wear of the wiper rubber (C) and condition of glass surface coating. In these cases there is normally no problem with the wiper blades (B), wiper arms (A) or backing rubber (D).

For dealer information, please be informed of confirmation points and repair methods in terms of poor window wiping issues. If part replacement is required, replace only the wiper rubber (C) and avoid unnecessary wiper assembly replacement.
