Subject: ENGINE COMPARTMENT SHROUD PANEL POOR APPEARANCE	Bulletin No: 09-034/09
	Last Issued: 07/10/2009

APPLICABLE MODEL(S)/VINS

- 2006-2010 MX-5
- 2004-2010 RX-8
- 2004-2010 Mazda3
- 2006-2010 Mazda5
- 2003-2010 Mazda6
- 2007-2010 CX-7
- 2007-2010 CX-9

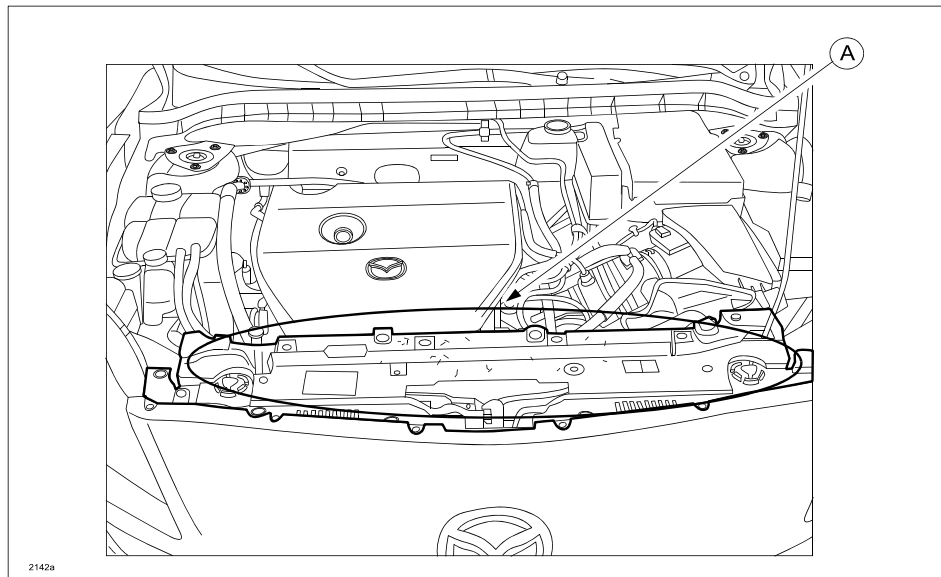
Some customers may complain of a poor appearance or white marks (A) on the surface of the plastic shroud panel when the hood is open. Please explain to the customer that the appearance is normal and does not require repair. The glass fiber contained in the plastic sometimes looks like white marks on the shroud panel surface. This is normal and does not affect vehicle performance.

NOTE: The shape of the white marks will vary in each vehicle.

Mixing glass fiber with plastic before molding provides high strength and light weight, which is not possible with plastic alone. The appearance concern does not affect vehicle performance and does not require repair.
