MULTI-MODEL REAR COMBINATION LAMP/FINISHER POOR APPEARANCE

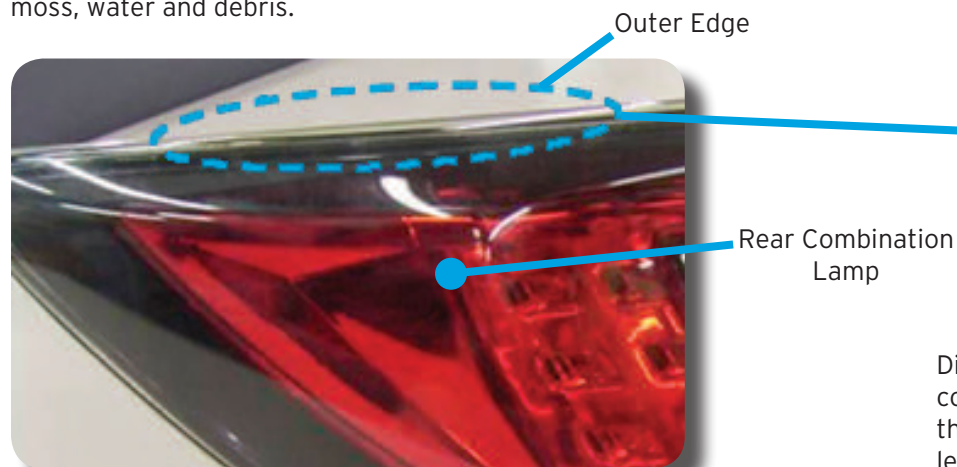
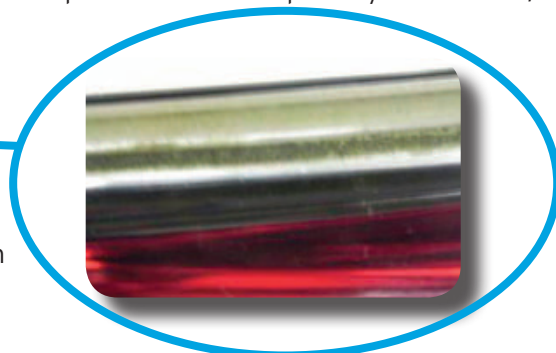
Some customers may complain about the poor appearance of the rear combination lamp and/or finisher. This may be caused by normal environmental conditions, such as dirt, moss, foreign particle adhesion, and/or water to the back side of the outer edge. Part replacement will not correct this concern. Refer below for the procedures to temporarily remove dirt/moss, water and debris.

Dirt/moss can stick to the back side of the combination lamp outer edge (not inside the lamp) and can be seen through the lens, causing poor appearance.
