Subject: SQUEAKING NOISE FROM CLUTCH PEDAL WHEN DEPRESSED	Bulletin No: 05-002/06
	Last Issued: 4/26/2006

2006 MX-5 vehicles with VINs lower than JM1 NC**** ** 111723 (produced before January 1, 2006)

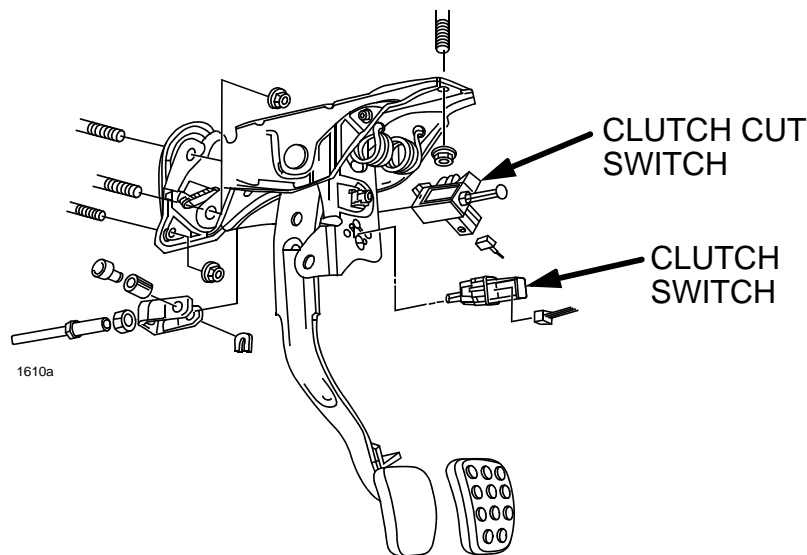
Some vehicles may exhibit a squeaking noise when the clutch pedal is depressed. The squeaking noise comes from the starter interlock switch.

As a mass-production change, the plastic material in the starter interlock switch has been changed. Customers having this concern should have their vehicle repaired using the following repair procedure.

1. Verify customer concern.
2. Replace starter interlock switch (referred to as Switch, Clutch Cut in EPC). See Workshop Manual section 05-10 CLUTCH PEDAL REMOVAL/INSTALLATION
3. Verify repair.
