Service Information

Category G	Technical	Ref. No. E001/14	Page 1 of 1
Coverage <input type="checkbox"/> Distributor only <input checked="" type="checkbox"/> Please inform your dealers		Date Issued January 6, 2014	
Please convey this information to your <input type="checkbox"/> Director <input checked="" type="checkbox"/> General Manager <input checked="" type="checkbox"/> Warranty Dept. <input checked="" type="checkbox"/> Parts Dept. <input checked="" type="checkbox"/> Training Dept. <input checked="" type="checkbox"/> Field Rep.		Date Revised	
Applicable Model All Models	Applicable Countries or Specifications Worldwide

Subject: Service Caution for Main Fuse Block Wiring

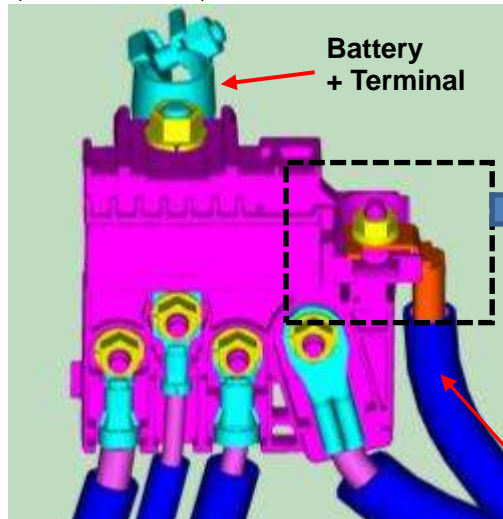
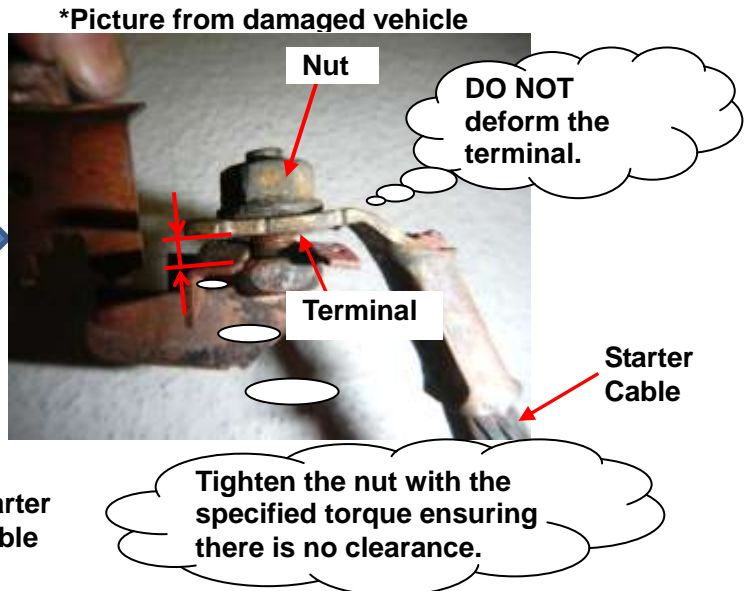
Sample: Main Fuse Box for CX-5
(SKYACTIV-D)

A smoldering out of the starter harness may happen due to the starter cable terminal not being securely tightened with the nut to the main fuse box during service.

As described, an improper tightening of electric terminals at locations where large currents flow may result in a vehicle fire in the worst case. This Service Information is issued to advise about the service cautions when connecting the starter cable terminal etc. Ensure that all appropriate personnel have been advised of this service information:

1. Tighten the nut with the torque specified in the workshop manual ensuring that the nut and the cable terminal are correctly seated without gap.
2. DO NOT deform the starter cable terminal at the time of removal.
