Service Information

Category S	Technical	Ref. No. E013/15	Page 1 of 3
Coverage <input type="checkbox"/> Distributor only <input checked="" type="checkbox"/> Please inform your dealers		Date Issued August 27, 2015	
Please convey this information to your <input type="checkbox"/> Director <input checked="" type="checkbox"/> General Manager <input checked="" type="checkbox"/> Warranty Dept. <input checked="" type="checkbox"/> Parts Dept. <input checked="" type="checkbox"/> Training Dept. <input checked="" type="checkbox"/> Field Rep.		Date Revised	
Applicable Model MX-5 (ND)		Applicable Countries or Specifications Worldwide

Subject: Possible Paint Damage to Trunk Lid Opening when removing Rear Combination Light [Service Note]

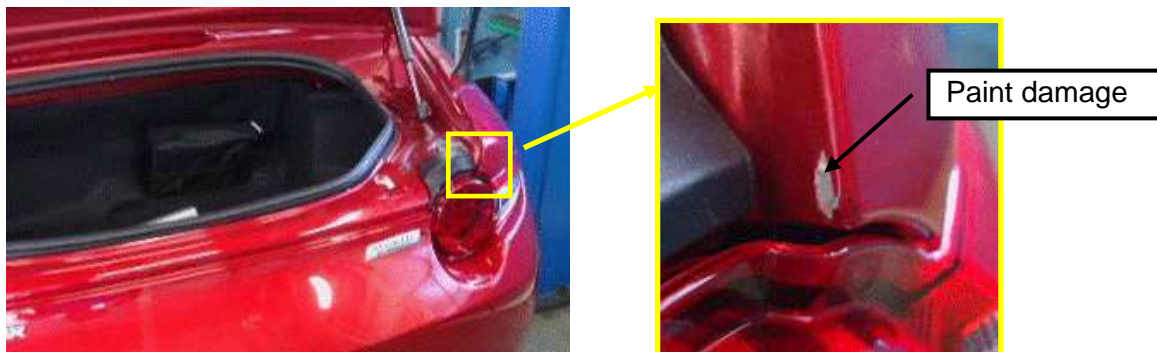
When removing the rear combination light, there is a possibility that paint damage may occur on the trunk lid opening where sealant is applied. To prevent this, please follow the service note in this Service Information.

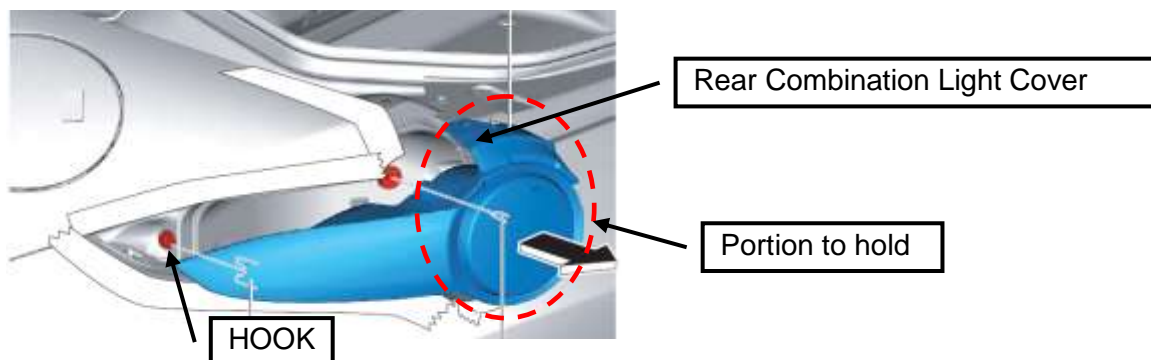
The rear combination light cover may warp toward and contact the trunk lid opening (sealant portion) if the combination light is pulled by holding the portion indicated in the figure to disengage the hook.

NOTE: There is no appropriate portion to hold and pull for disengaging the hook straight.

NOTE: Even if a protective tape is used, the paint may peel off when removing the tape if the sealant is cracked by the contact over the tape.

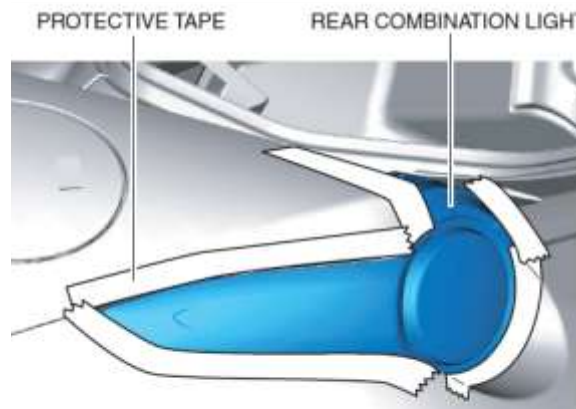
- When removing the rear combination light from the body, it could interfere with the body and cause scratching or damage to the body. When removing the rear combination light from the body, apply protective tape to the body.

7. To prevent scratches or damage, affix protective tape to the position shown in the left figure.

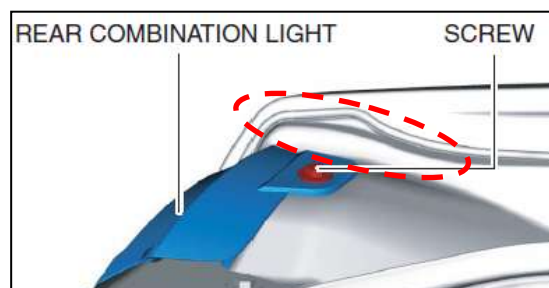
DO NOT use a protective tape having strong adhesive force, or the paint may peel off when removing the protective tape.

Affix three layers of protective tape to the portion shown in the right figure.
