2008-2013 MX-5

POWER RETRACTABLE HARDTOP WILL NOT OPEN / CLOSE AND / OR RATTLE TYPE NOISE

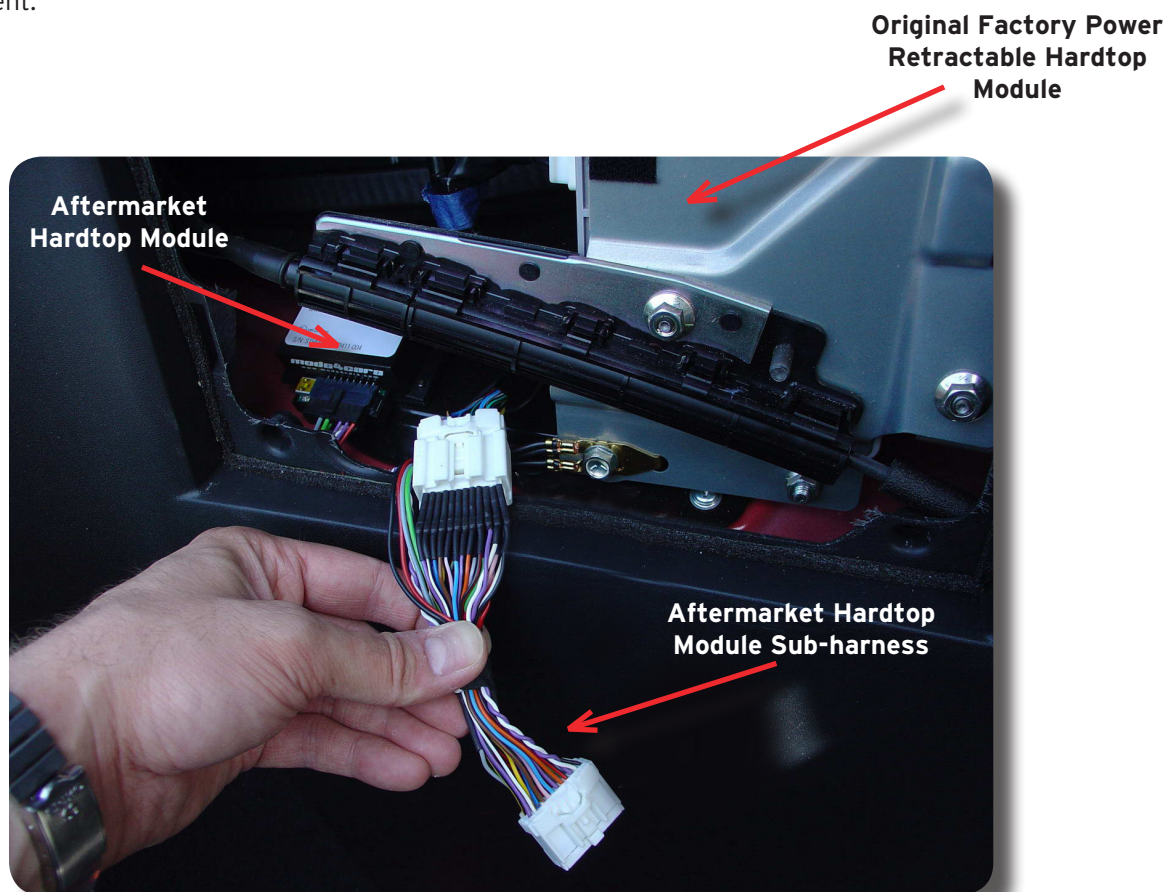
These concerns may be caused by an aftermarket device (see image below) allowing the hardtop to open or close when the vehicle is in motion.

This condition may overstress the hardtop retractable motors and linkages, causing premature motor failure and/or linkage misalignment.

Replacement of the power retractable hardtop motor(s) or linkage adjustments are not covered under Mazda's warranty policy if the vehicle has been modified.
