<b>Subject:</b> <b>SEAT BELT COMES OUT OF SEAT BELT GUIDE WHEN RETRACTING</b>	<b>Bulletin No:</b> 08-002/16
	<b>Last Issued:</b> 04/29/2016

2016 MX-5 vehicles with VINs lower than JM1ND\*\*\*\*\*108746 (produced before December 14, 2014)

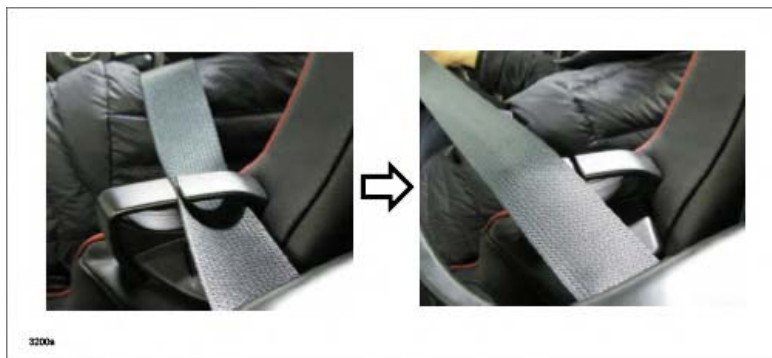
Some customers may complain that the seat belt comes out of the seat belt guide when the seat belt retracts as shown because the shape of the seat belt guide is inadequate.

1. Verify customer concern.
2. Remove two philips head screws on the seat belt guide, then replace the seat belt guide with a modified one (both sides).
3. Verify repair.

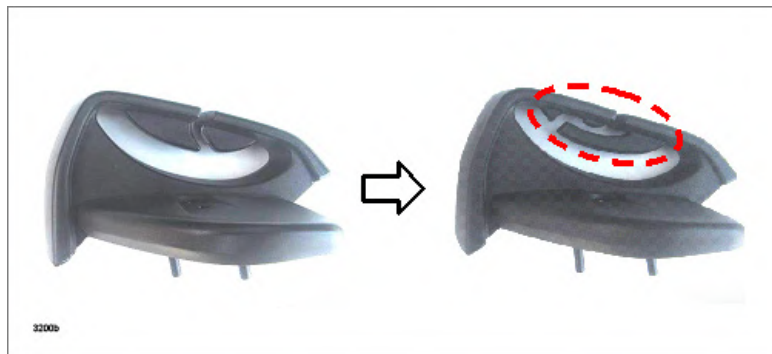
To correct the problem, the shape of the seat belt guide has been changed.
