Service Information

Category S	Repair Guidance	Ref. No. R025/16C	Page 1 of 2
Coverage <input type="checkbox"/> Distributor only <input checked="" type="checkbox"/> Please inform your dealers		Date Issued March 17, 2016	
Please convey this information to your <input checked="" type="checkbox"/> Warranty Dept. <input checked="" type="checkbox"/> Parts Dept. <input type="checkbox"/> Training Dept. <input type="checkbox"/> Field Rep.		Date Revised April 11, 2017	
Applicable Model MX-5 (ND)		Applicable Countries or Specifications Worldwide

Subject: Squeak noise when power window is moved up and/or down

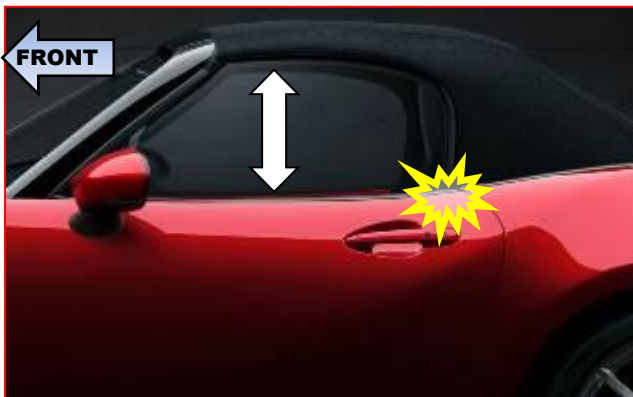
The noise occurs when the door glass is moved/rolled up and/or down with the door closed.

This is caused by stick-slip noise occurring at the contact surfaces between the door glass and the weather strip. By repeated moving up and down, the anti-noise paint on the weather strip peels off.

When you encounter a customer complaint on this concern, remove the door trim by referring to workshop manual DOOR TRIM REMOVAL/INSTALLATION, then replace the weather strip with a modified one for both doors.

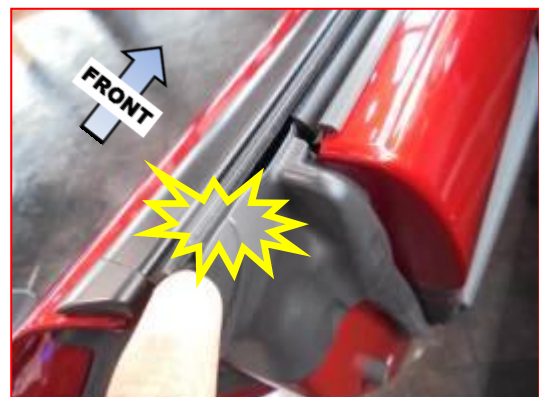
To show the noise source more clearly, the door glass is moved down.
