Subject: GRINDING NOISE FROM CLUTCH PEDAL WHEN DEPRESSING	Bulletin No: 05-003/16
	Last Issued: 02/10/2016

2016 MX-5 vehicles with VINs lower than JM1ND*****104047 (produced before August 7, 2015)

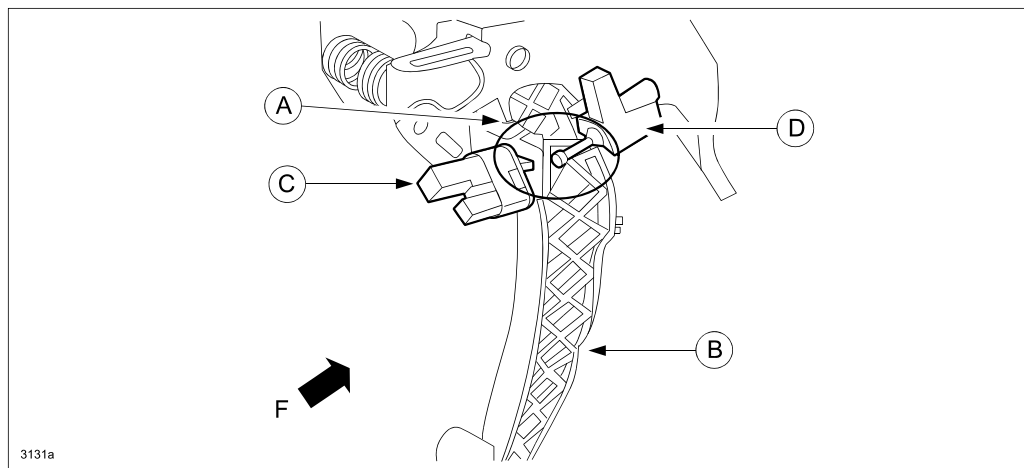
Some vehicles may exhibit a grind noise from around the clutch pedal when depressing it all the way down. This is caused by a stick-slip noise occurring at the contact point (A) between the clutch pedal (B) and the clutch pedal position switch (C) plunger and/or the clutch pedal and the starter interlock switch (D) plunger (F: Vehicle front).

To prevent the stick-slip noise from occurring, two pieces of silicon pad have been attached to the clutch pedal where the two switches contact.
