Subject: WATER LEAK ABOVE SIDE WINDOWS	Bulletin No: 09-036/06
	Last Issued: 9/1/2006

2006 MX-5 vehicles with VINs lower than JM1 NC**** ** 111535 (produced before December 27, 2005)

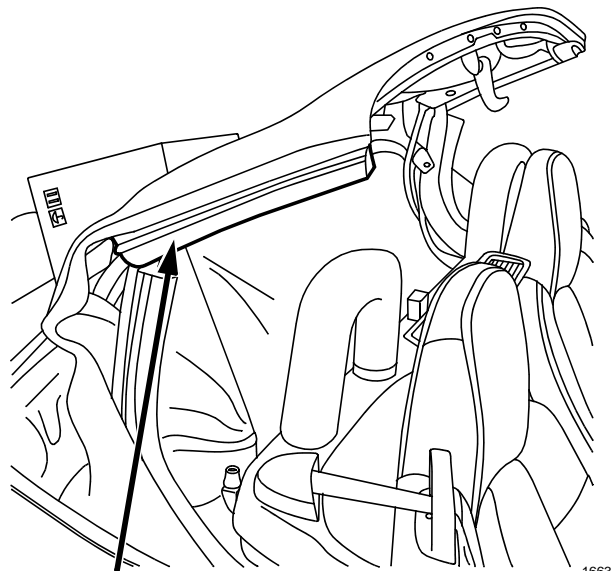
WEATHERSTRIP

Some vehicles may experience water leaks into the vehicle cabin from under the weather-strip above the side windows. As a mass production change, the sealing of the soft top cloth at the weather-strip retainer has been improved.

- The water leak addressed in this bulletin is between the weather-strip retainer and the soft top, NOT between the weather-strip and the window.
