TSB: 01-018/15

MULTI-MODEL - CHECK ENGINE LIGHT ON WITH DTC P2610 AND P2507

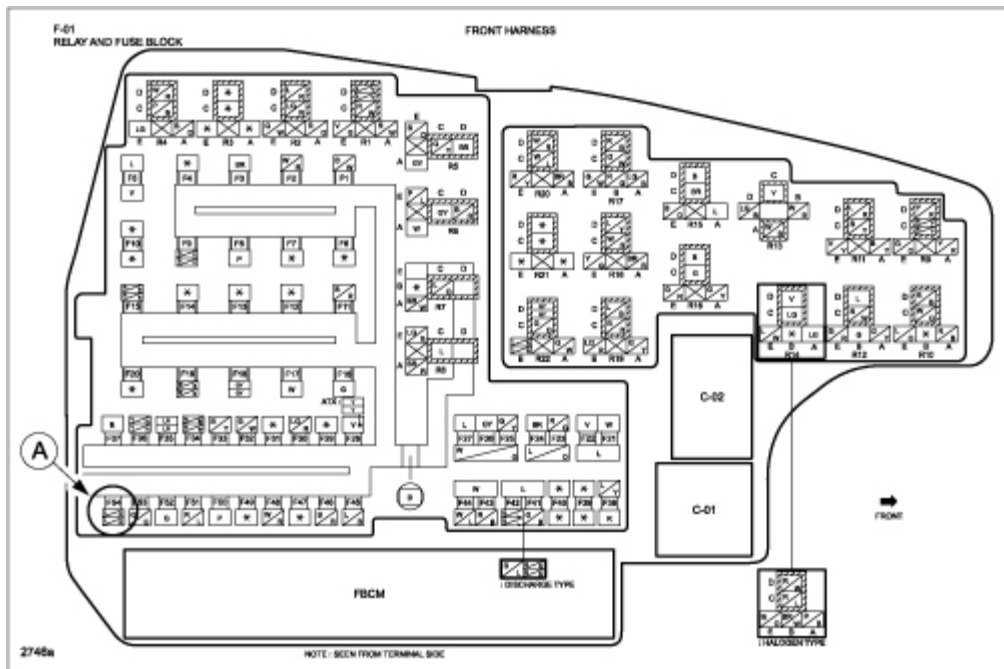
Some vehicles may experience the CHECK ENGINE LIGHT ON with DTC P2610 and P2507 stored in memory after engine start and room fuse 15A (A) removed.

- P2610:00: Instrument cluster internal engine off timer performance problem
- P2507:00: PCM battery voltage low input

As a past malfunction, the customer will not notice it (no warning light illuminated), but the DTC may be found during a vehicle service. P2507 in this situation is only applicable on 2016 and later models.

This is caused by the engine being started 3 or more times after a short duration of engine off (less than 15 seconds) with the room fuse removed.

1. Verify DTC P2610 and P2507 are stored in PCM memory.
2. Install ROOM fuse 15A with ignition OFF.
3. Start the engine and let it run for at least 10 seconds, then stop the engine.

4. Start the engine again and verify that the CHECK ENGINE LIGHT is not illuminated, then stop the engine.

5. Clear DTC P2610 and P2507 from PCM memory using IDS.

6. Verify no other DTCs are stored in memory. If so, troubleshoot them according to the MS3 online instructions or Workshop Manual.

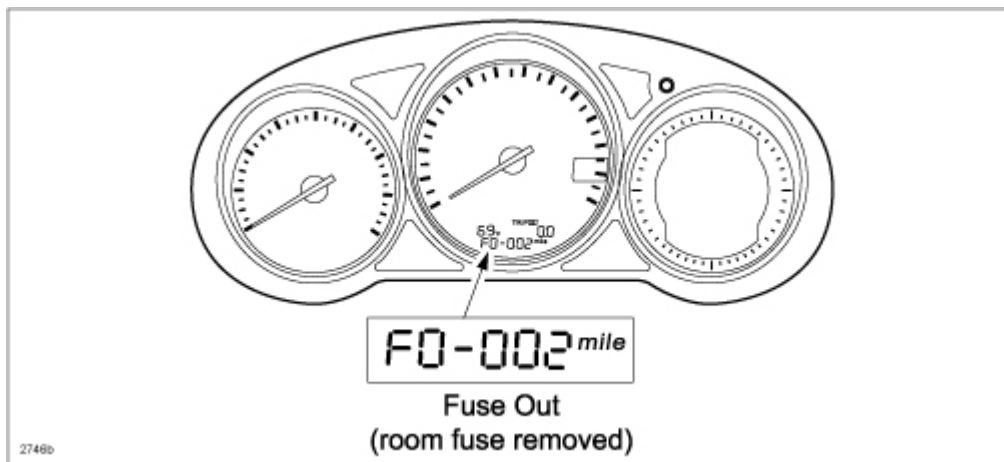
NOTE: The odometer will display "F0-002" during transport mode (room fuse 15A removed). Transport mode is canceled when room fuse 15A is installed or the vehicle odometer is more than 12.4mi (20km).
