Subject: FRONT BRAKE CREAKING AT LOW SPEEDS	Bulletin No: 04-004/07
	Last Issued: 8/3/2007

2006-2007 MX-5 with VINs before JM1 NC**** ** 131172 (built before November 10, 2006)

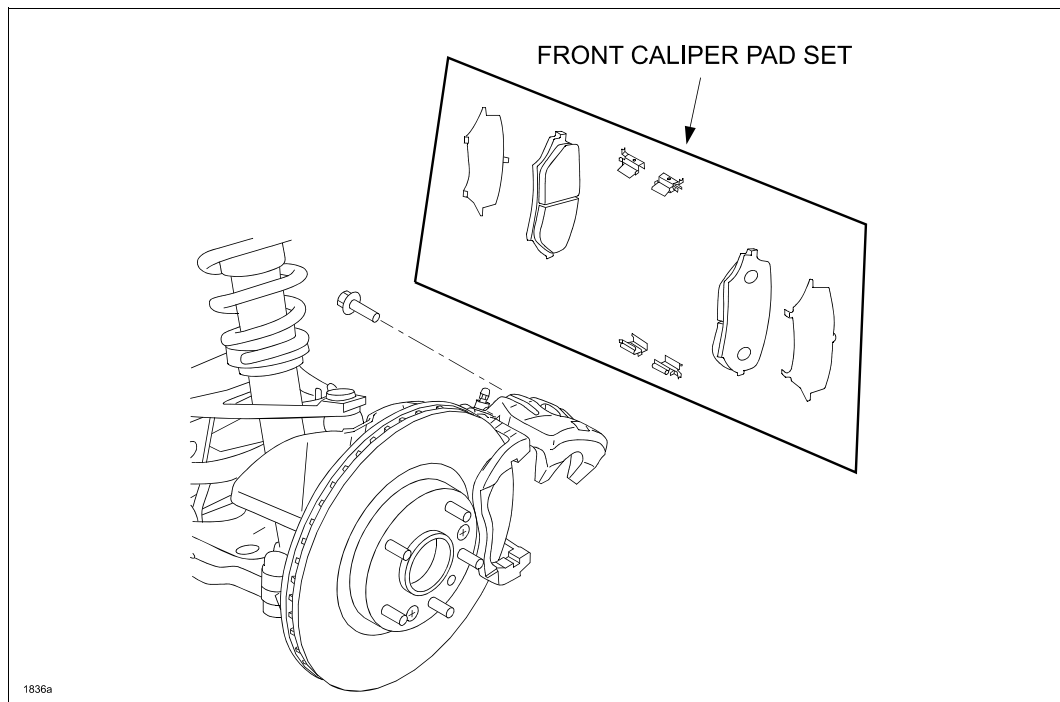
Some vehicles may exhibit a creaking noise when the brake pedal is gently depressed while driving at low speeds. The creaking noise is due to resonance of the front brake pad guide plate. The thickness of the guide plates have been increased to correct this concern.

1. Verify customer concern.
2. Replace front caliper pad set with modified parts (NFY7-33-23ZB). Refer to Workshop Manual section 04-11 DISC PAD (FRONT) REPLACEMENT.
3. Verify repair.
