<b>Subject:</b> SQUEAK AND/OR RATTLE NOISE FROM FRONT SEAT BELT BUCKLE	<b>Bulletin No:</b> 08-003/09
	<b>Last Issued:</b> 05/22/2009

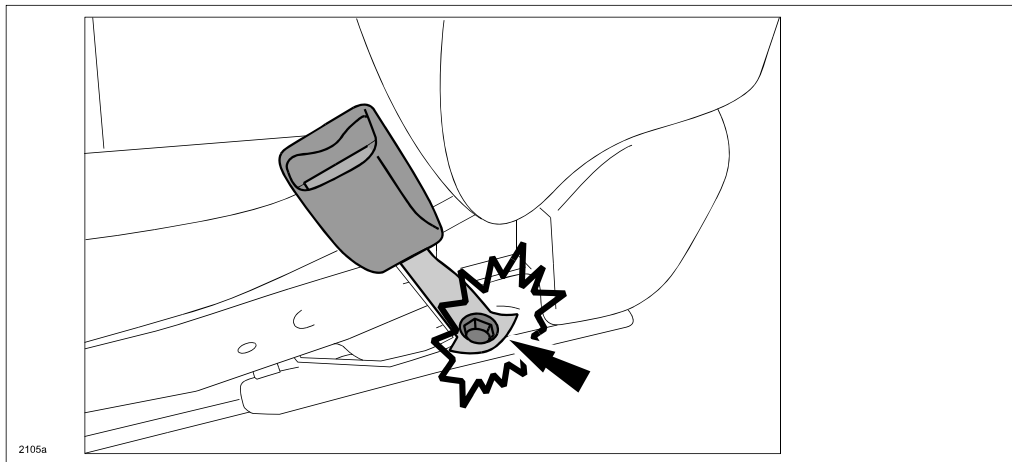
A squeak and/or rattle noise may come from the driver side seat while driving on slightly uneven road surfaces. Due to assembly variation, the bolt and washer may come in contact with each other causing the noise.

The diameter of the bolt flange has been increased during mass-production.
