Service Bulletin

Subject: Bulletin No: 09-021/09

WATER ACCUMULATION IN FOOTWELL / PLUGGED SOFT TOP DRAINS

Last Issued: 07/17/2009

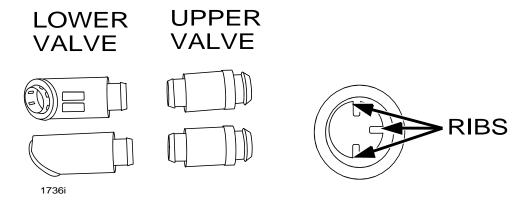
NOTE: The modified valves can be identified by the ribs inside the valve.

2. Replace the upper and lower valves with modified ones.
