Service Information

Category M	Repair Guidance	Ref. No. R102/15	Page 1 of 3
Coverage <input type="checkbox"/> Distributor only <input checked="" type="checkbox"/> Please inform your dealers		Date Issued October 15, 2015	
Please convey this information to your <input type="checkbox"/> Director <input checked="" type="checkbox"/> General Manager <input checked="" type="checkbox"/> Warranty Dept. <input checked="" type="checkbox"/> Parts Dept. <input checked="" type="checkbox"/> Training Dept. <input checked="" type="checkbox"/> Field Rep.		Date Revised	
Applicable Model MX-5 (ND)		Applicable Countries or Specifications Worldwide

Subject: Creak noise from vehicle underneath at the rear when clutch is engaged quickly or the vehicle accelerating/decelerating rapidly

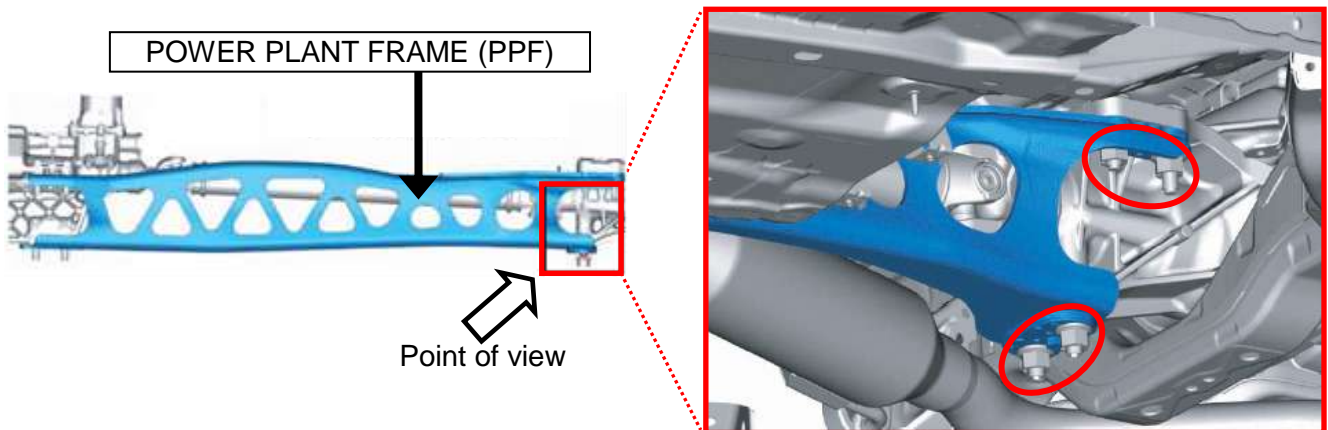
This is a stick-slip noise occurring at the contact surface between the power plant frame (PPF) and the rear differential.

The tightening torque of the stud bolts and nuts has been increased to avoid this concern.
