Section <b>07</b>	Applicable Model/s <b>1995-98 Protege 1996-97 Miata</b>	Subject <b>A/C INOPERATIVE - P/S PRESSURE SWITCH TERMINAL ASSEMBLY CORRODED</b>	Bulletin No. <b>001/00</b>
			Issued <b>02/07/00</b>
			Revised

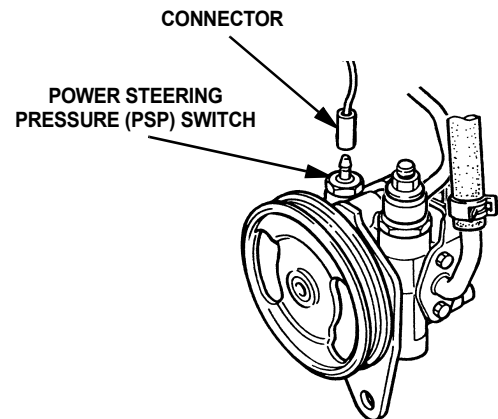
Some vehicles may exhibit the air conditioning (A/C) system inoperative with the Malfunction Indicator lamp (MIL) ON. This may be due to the Power Steering Pressure (PSP) switch terminal assembly becoming corroded causing the Powertrain Control Module (PCM) to open the A/C relay circuit and set Diagnostic Trouble Code (DTC) P0550. A modified PSP switch terminal assembly is available to resolve this concern.

- Verify customer concern.
- Turn the A/C system ON and disconnect the PSP switch.
  - If the A/C system does not function, refer to the Workshop Manual for troubleshooting and repair information.
  - If the A/C system operates, replace only the PSP switch terminal assembly.
