Subject: KEYLESS ENTRY SYSTEM - DOORS CANNOT BE LOCKED/UNLOCKED USING TRANSMITTER - BATTERY IS OK	Bulletin No: 09-035/06
	Last Issued: 8/14/2006

APPLICABLE MODEL(S)/VINS

2006 Mazda5 vehicles with VINs lower than JM1 CR**** ** 123133 (produced before March 1, 2006)

2006 MX-5 vehicles w/o Advanced Keyless with VINs lower than JM1 NC**** ** 115201 (produced before March 1, 2006)

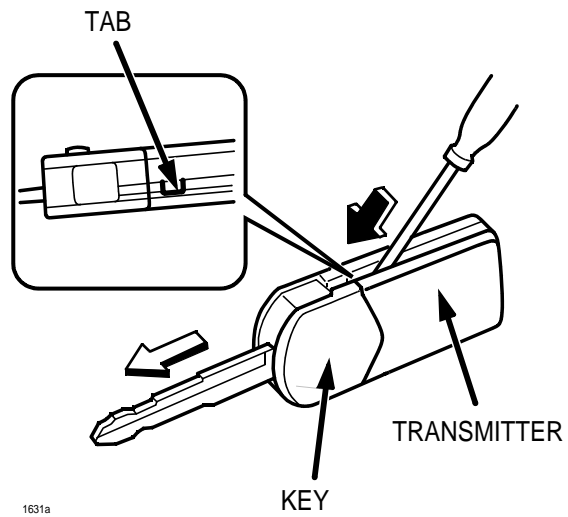
3. Remove the transmitter battery.
 - a. Insert a small screwdriver into the slot and push the tab to remove the key from the transmitter.

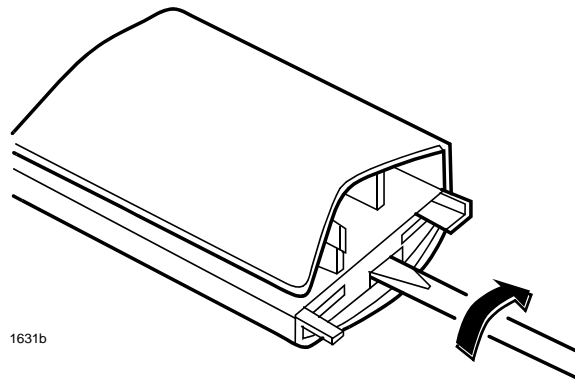
- b. Insert a small screwdriver into the slot and gently twist to pry open the transmitter and access the battery.

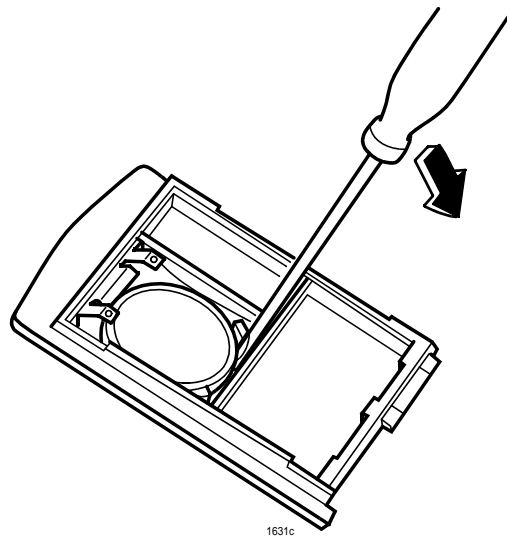
- c. Remove the battery.

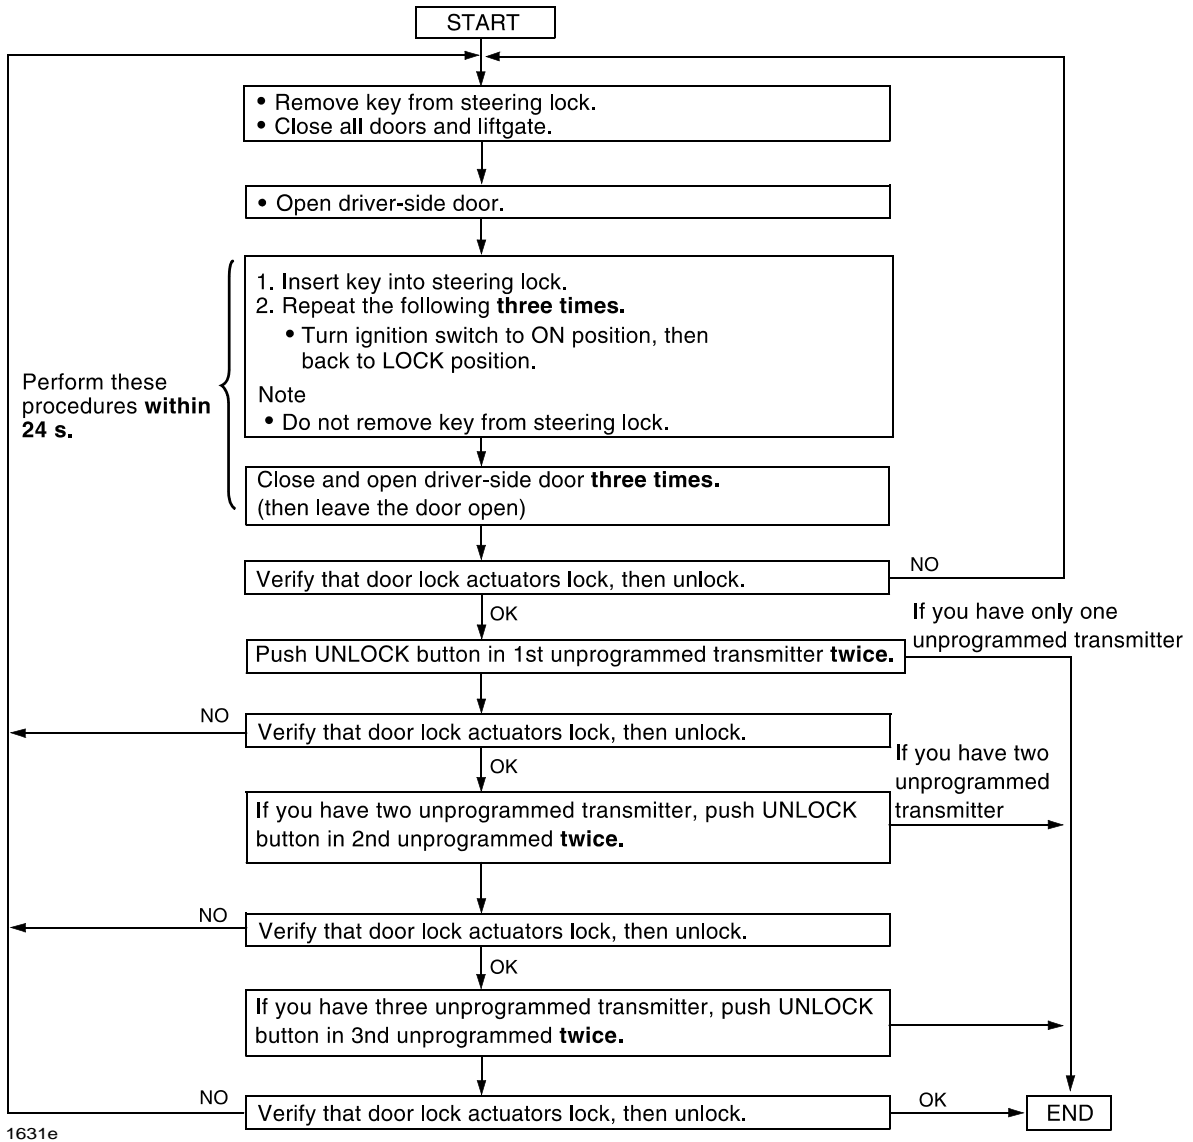
TYPE A PROCEDURE**CAUTION:**

- After ID code programming, remove the key from the steering lock and verify that all doors lock and unlock normally using the transmitter.

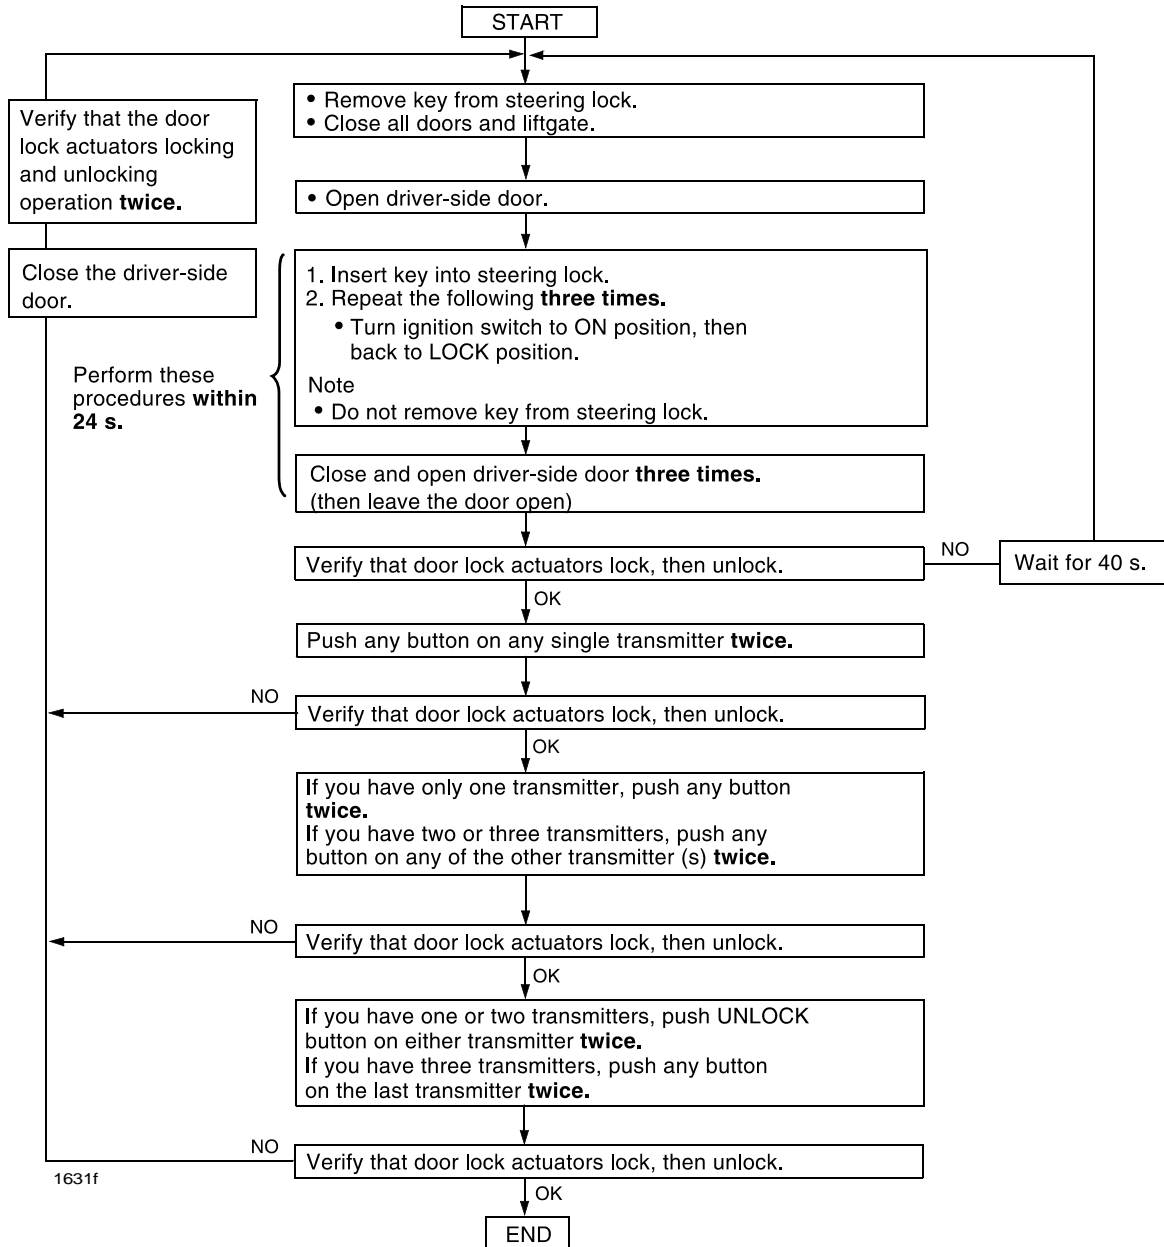
TYPE B PROCEDURE

- After ID code programming, remove the key from the steering lock and verify that all doors lock/unlock normally using the transmitter.
