Subject: MIL ILLUMINATION - DTC P0441	Bulletin No: 01-003/09
	Last Issued: 03/20/2009

APPLICABLE MODEL(S)/VINS

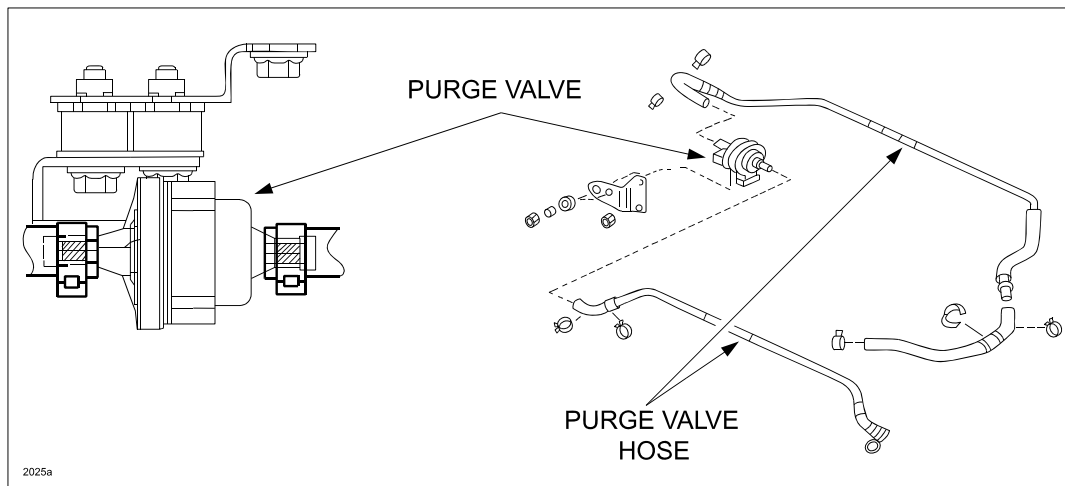
Some vehicles may experience a MIL illumination with DTC P0441 stored in PCM memory. This may be caused by a stuck (closed) purge solenoid valve.

- DTC P0441: Evaporative emissions control system incorrect purge flow.

The purge solenoid valve manufacturing process has been changed to eliminate this concern. Customers having this concern should have their vehicle repaired using the following repair procedure.

1. Verify customer concern.
2. Perform airflow inspection of purge solenoid valve according to appropriate Workshop Manual.
 - If purge solenoid valve is found to be stuck closed, proceed to Step 3.
 - If purge solenoid valve is not found to be stuck closed, refer to appropriate Workshop Manual (on MS3) for additional diagnostics.

3. Replace purge solenoid valve according to appropriate Workshop Manual.
4. Verify repair.
