<b>Subject:</b>  REPLACEMENT OF WATER PUMP FOR COOLANT LEAK	<b>Bulletin No:</b> 01-004/09
	<b>Last Issued:</b> 02/03/2009

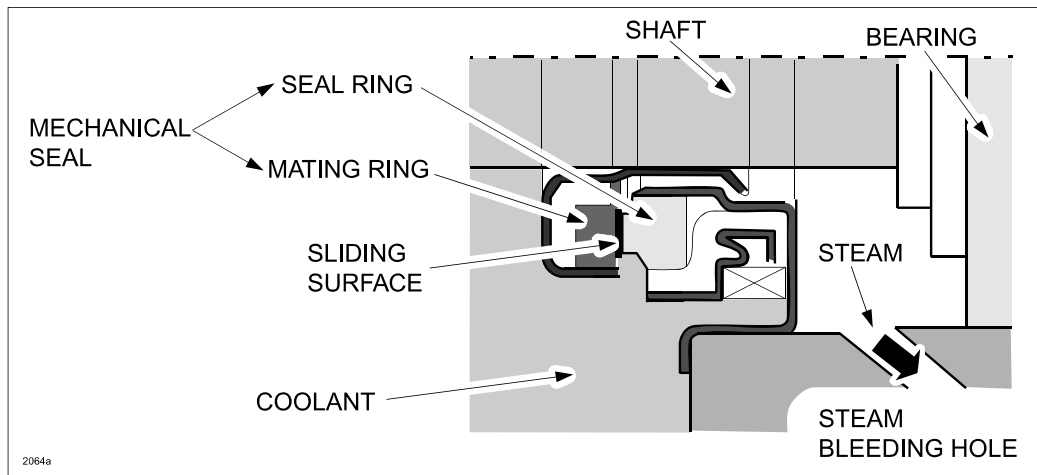
A mechanical seal is used for the water pump, and this mechanical seal can seal coolant by sliding a mating ring against a seal ring. When the sliding surface temperature of the mechanical seal is more than 248 °F (120 °C) while driving, a small amount of steam is leaked and bleeds through the bleeding hole. After drying, the steam leaves a coolant leak mark on the water pump. This is normal, and the water pump should not be replaced. The water pump should only be replaced if there is an accumulation of crystallized coolant around the bleed hole.

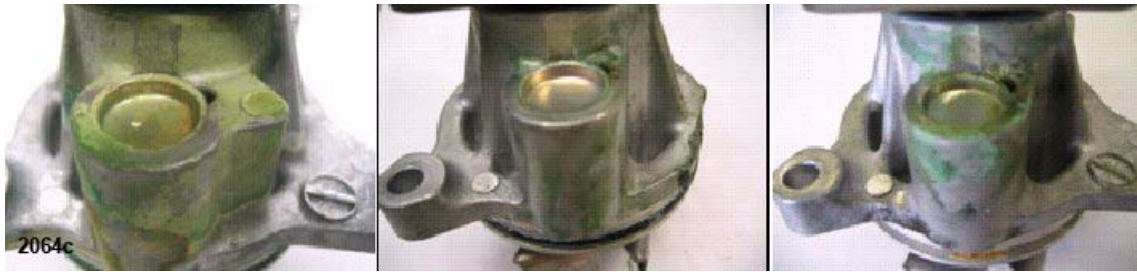
Water Pump OK: No accumulation of crystallized coolant

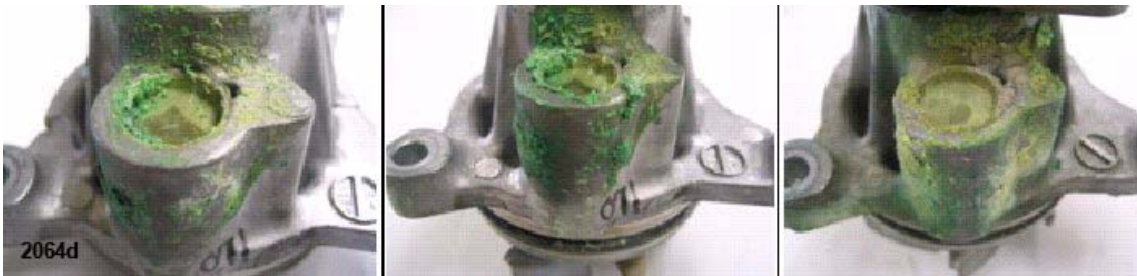
Water Pump NOT OK: Accumulation of crystallized coolant
