<b>Subject:</b>  SERVICE CAUTION FOR TPMS	<b>Bulletin No:</b> 02-003/11
	<b>Last Issued:</b> 06/23/2011

2006-2011 MX-5	2007-2011 CX-9	2004-2011 Mazdaspeed3	2008-2011 Mazda6
2004-2011 RX-8	2004-2011 Mazda3	2006-2010 Mazda5	
2007-2011 CX-7	2011 Mazda2	2012 Mazda5

It is important to follow the proper procedure for vehicles equipped with TPMS (Tire Pressure Monitoring System). Failure to do so may result in damage/breakage of the TPMS sensor and/or a decrease in pressure due to corrosion of the TPMS valve.

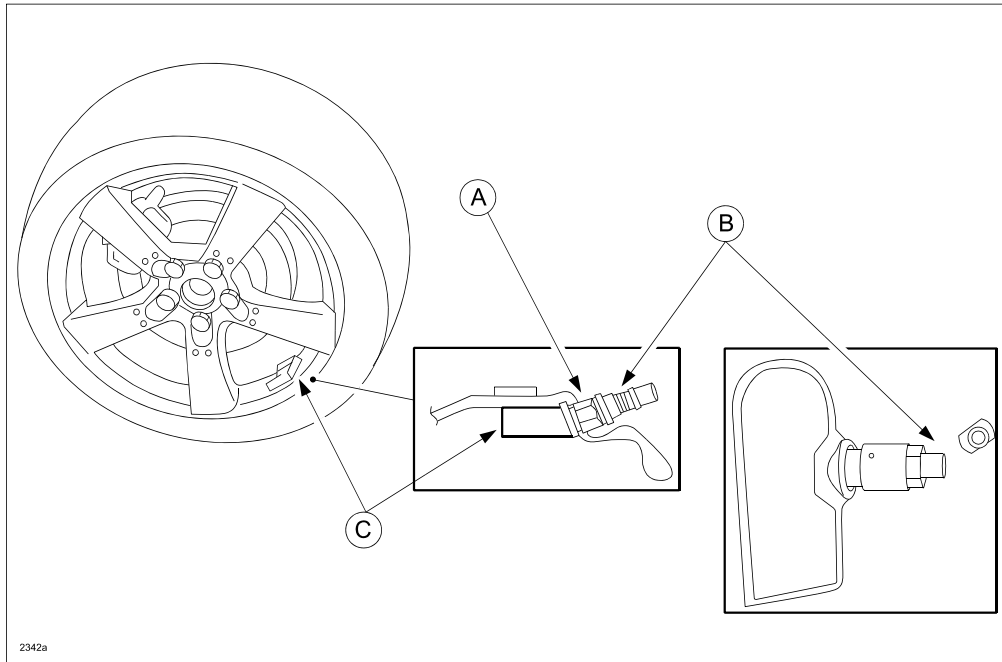
Some vehicles may experience the aluminum valve stem (B) breaking off of the TPMS wheel unit (C) when removing aftermarket valve stem caps during procedures such as routine checking of air pressure in tires.

- TPMS sensor nut (A): Initial torque 67-75 in-lbf (7.5-8.5 Nm)

1. DO NOT use metal stem caps:

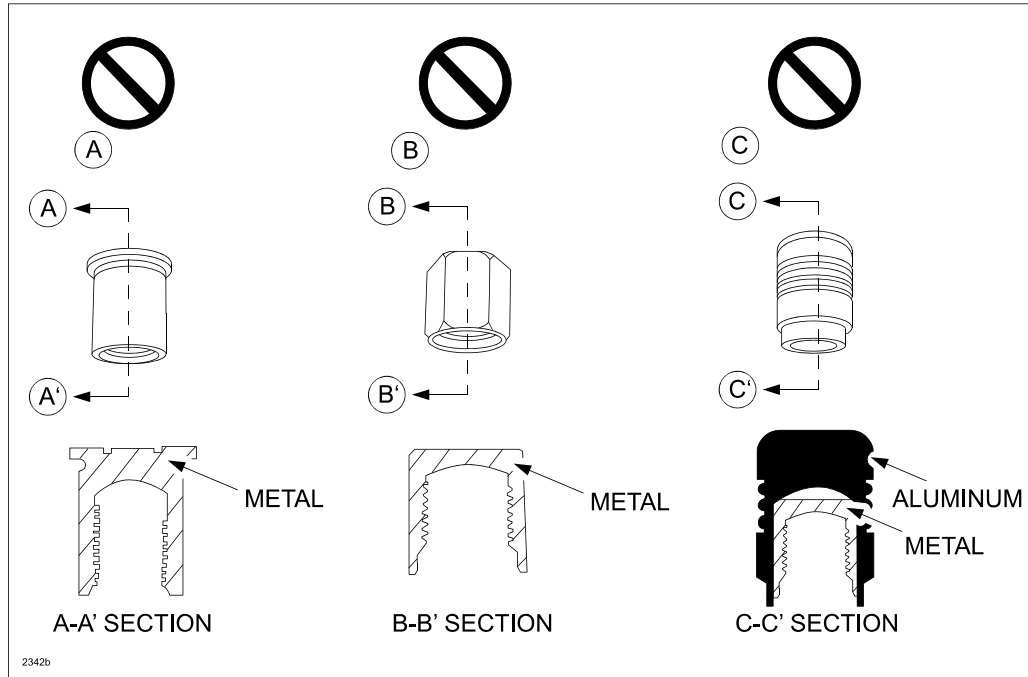
TYPICAL AFTERMARKET VALVE STEM CAPS

Some aftermarket valve stem caps are made of metal or have thread inserts that are made of metal. Examples of these types of aftermarket valve stem caps are shown below. When metal and aluminum are together in such a condition, galvanic corrosion occurs between the aluminum valve stem of the TPMS sensor unit and the metal threads of the valve stem cap. This corrosion can cause them to fuse together, becoming difficult to remove by hand. When more force is used to remove the valve stem cap, the aluminum valve stem of the TPMS sensor unit will break off and the TPMS sensor unit will need to be replaced.

- (A) - Metal
- (B) - Chrome over metal
- (C) - Aluminum with metal insert

This service bulletin can aid in informing customers of the damage that may be caused to the TPMS sensor units by installing these types of valve stem caps. Advise customers to use aluminum or plastic caps ONLY. Also, ensure that the caps they choose to install DO NOT have a metal thread insert.

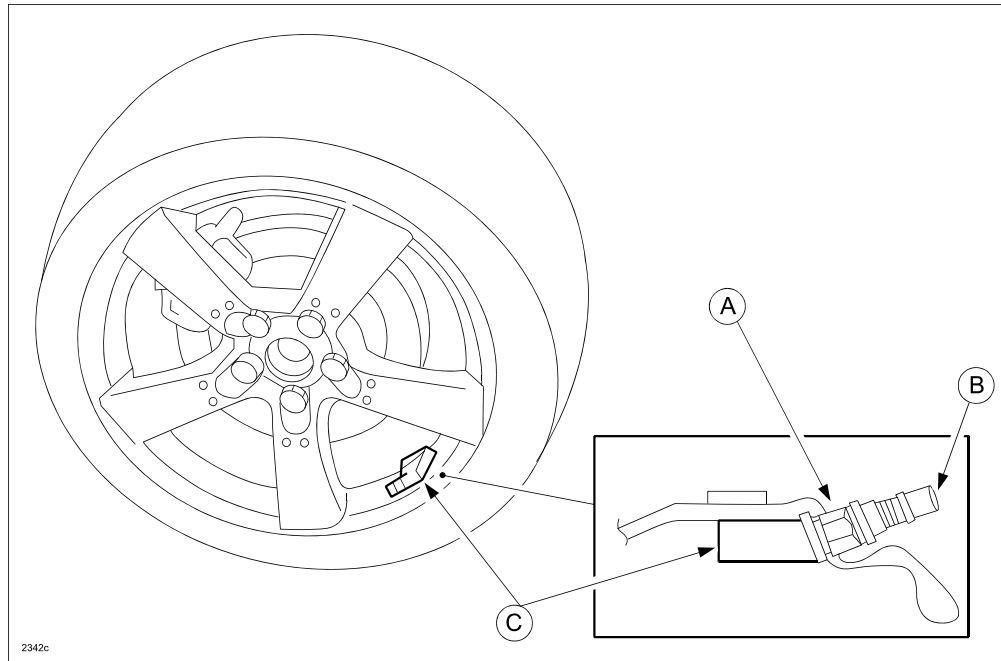
2. Torque TPMS sensor nut (A) and valve core (B) properly:  
Excessive torque on TPMS sensor nut and/or valve core may result in damage/breakage of the valve stem.

**NOTE:** The torque of the TPMS sensor nut slightly decreases after filling the tire with air. 17.7-26.6 in-lbf (2-3 Nm) is acceptable at this stage. DO NOT retighten after that.

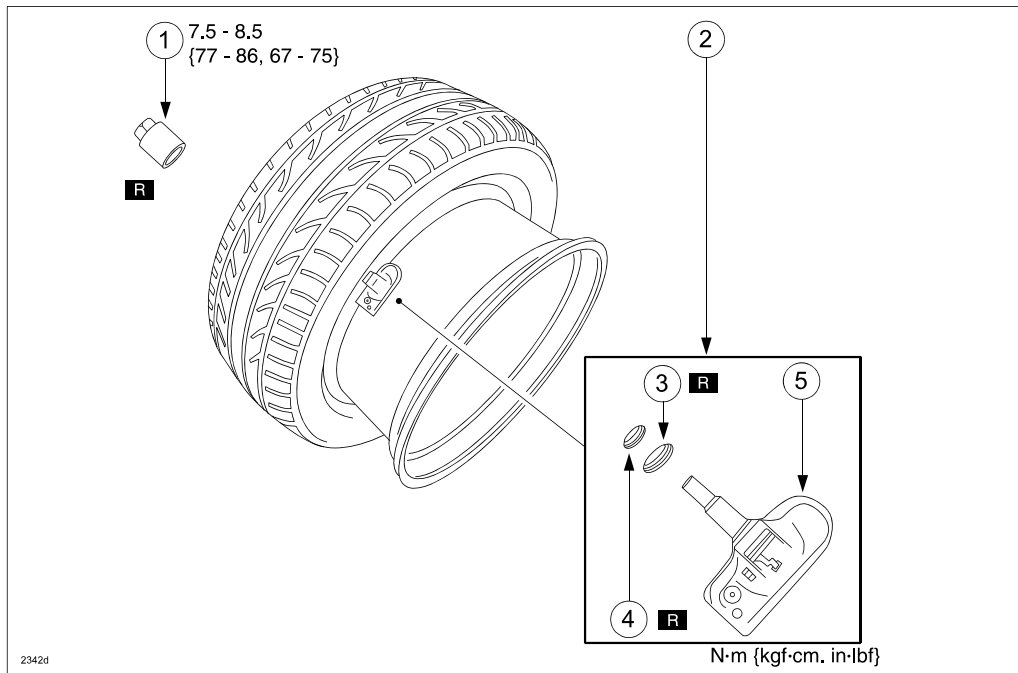
- 1) TPMS sensor nut
- 2) TPMS sensor components
- 3) Seal washer
- 4) Seal
- 5) TPMS sensor

3. Replace TPMS sensor nut when TPMS sensor (C) is detached:  
The TPMS sensor nut must be replaced with seal washer and seal when TPMS sensor is detached from the wheel.
