Service Information

Category T	Repair Guidance	Ref. No. R059/17	Page 1 of 5
Coverage <input type="checkbox"/> Distributor only <input checked="" type="checkbox"/> Please inform your dealers		Date Issued August 22, 2017	
Please convey this information to your <input type="checkbox"/> Director <input checked="" type="checkbox"/> General Manager <input checked="" type="checkbox"/> Warranty Dept. <input checked="" type="checkbox"/> Parts Dept. <input checked="" type="checkbox"/> Training Dept. <input checked="" type="checkbox"/> Field Rep.		Date Revised	
Applicable Model MX-5 (ND) with Bose® Speakers		Applicable Countries and/or Vehicle Specifications Worldwide

Subject: Buzzing from Driver and/or Passenger-side Headrest Speaker(s) when playing radio or other audio media

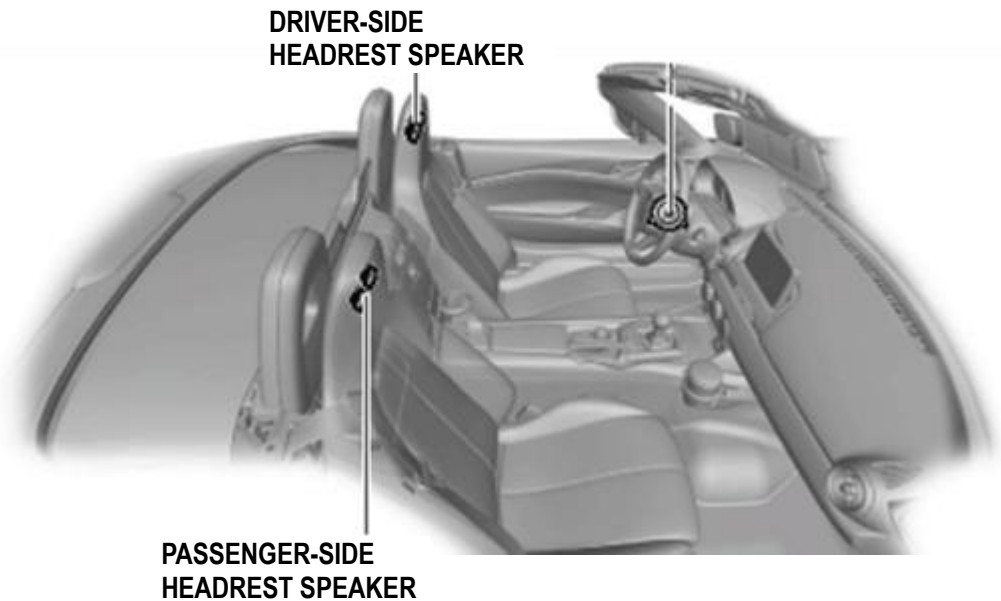
Some vehicles may exhibit a buzzing from the driver and/or passenger-side headrest speaker(s) when playing radio or other audio media.

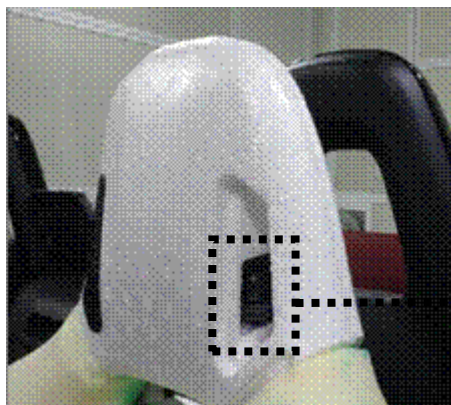
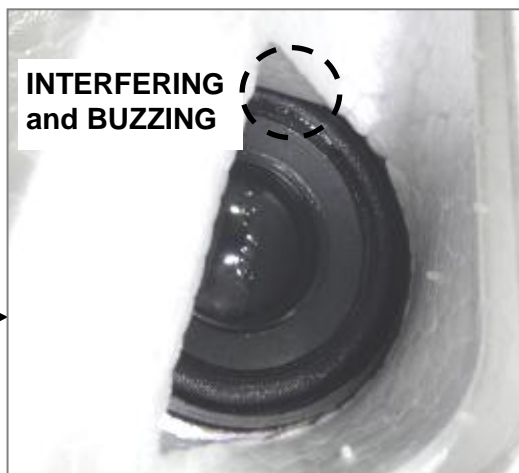
DRIVER SIDE HEADREST PAD
- after removing Seat Back Trim-

The upper part of the speaker cone is interfering with the headrest pad causing buzzing.

The shape of the headrest pad will be changed to assure sufficient clearance between the speaker and the headrest pad.
