Subject: SEALANT APPEARS BETWEEN CASE AND EXTENSION HOUSING - SERVICE TIP	Bulletin No: 05-003/06
	Last Issued: 5/8/2006

2006 MX-5 vehicles equipped with 6-Speed Automatic Transmission produced after March 10, 2006

2006 RX-8 vehicles equipped with 6-Speed Automatic Transmission

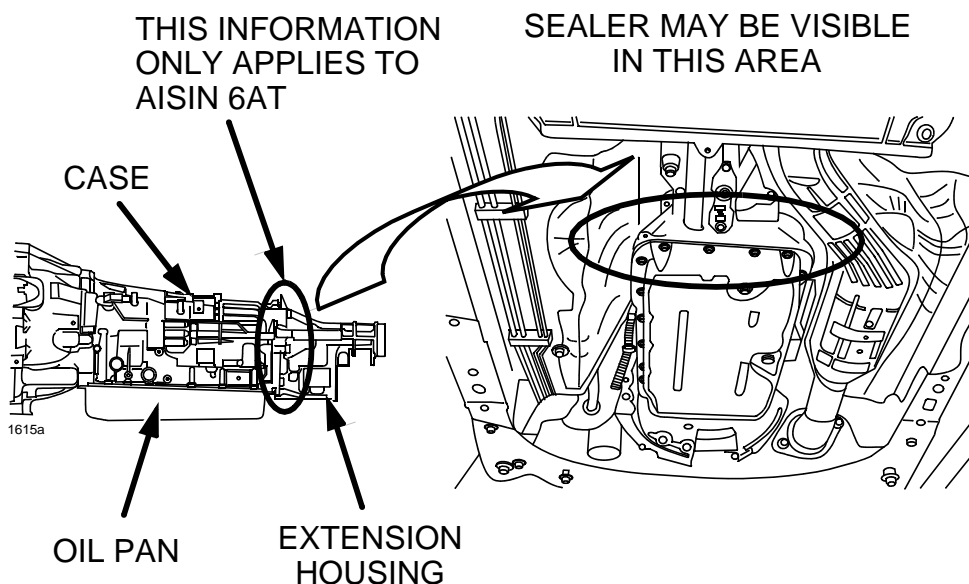
Some vehicles with 6-speed automatic transmissions there may be what appears to be excessive sealant around the joint between the automatic transmission case and the extension housing. This is most noticed around the lower 2 bolts attaching the extension housing to the transmission case. This sealer has been applied to this area to prevent ATF seepage and is NOT a cause for concern or repair.
