© 2006 Mazda Motor of America, Inc.

Subject: WATER LEAK AT FRONT OF CONVERTIBLE TOP	Bulletin No: 09-013/06
	Last Issued: 4/20/2006

APPLICABLE MODEL(S)/VINS

2006 MX-5 with VINs lower than JM1 NC**** ** 113573 (produced before February 1, 2006)

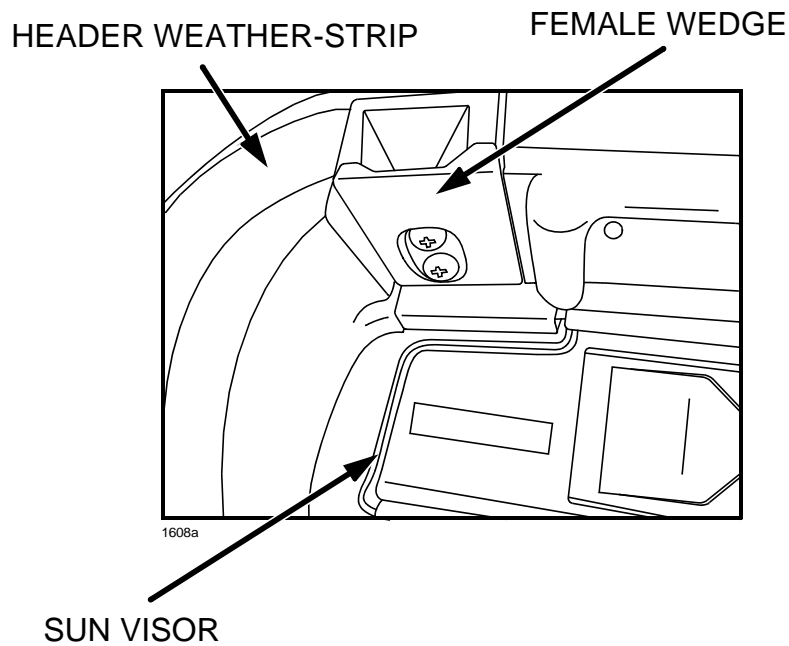
Customers may complain that during heavy rain, some vehicles may experience water leakage around the female wedge. Water is not completely draining from the drain hole and enters between the header weather-strip and windshield header panel.

As a mass-production change, a pad has been added to the area between the header weather-strip and windshield header panel. Customers having this concern should have their vehicle repaired using the following repair procedure.

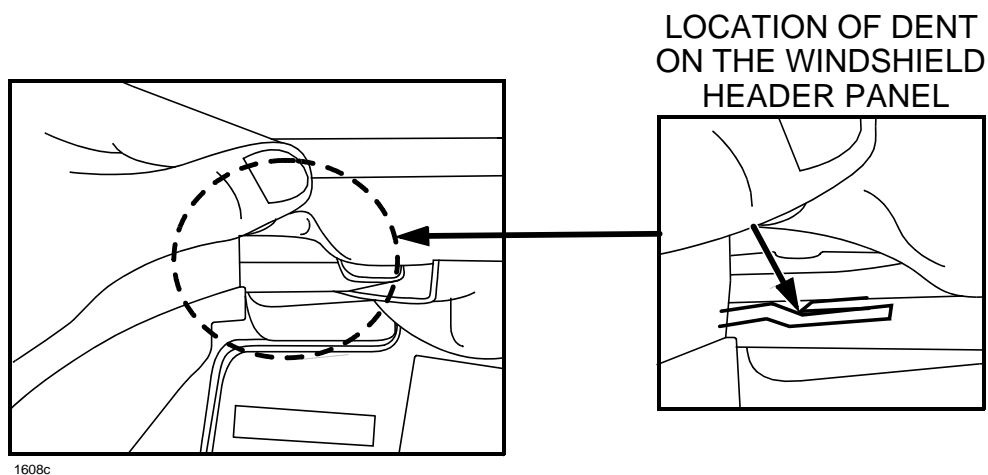
1608c

3. Roll up the lip of the weather-strip and confirm there is an indentation (dent) in the windshield header panel.
