Subject: SQUEAKING NOISE AROUND REAR CENTER CONSOLE LID	Bulletin No: 09-026/06
	Last Issued: 6/27/2006

2006 MX-5 vehicles with VINs lower than JM1 NC**** ** 118186 (produced before May 10, 2006)

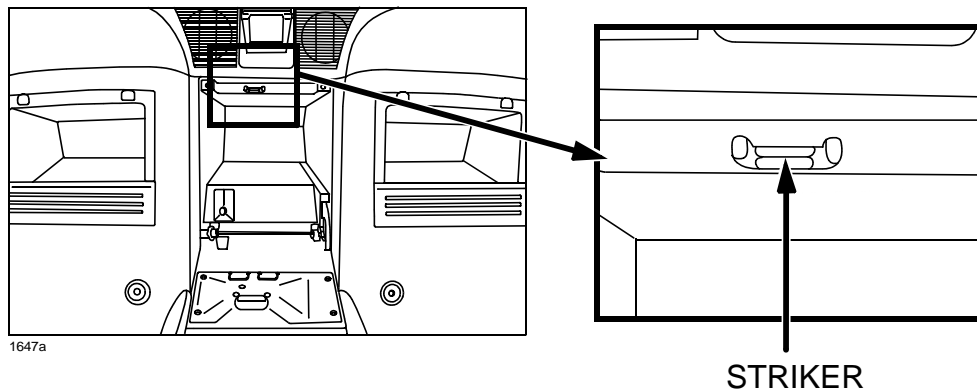
BACK TRIM WITHOUT STORAGE BOX LIDS SHOWN

Some vehicles may exhibit a squeaking noise from around the rear center console lid area when driving on a rough road or turning corners at slow speeds. Torque of the rear center console lid striker screw is insufficient. The tightening process has been revised in production.

3. Remove the back trim. Refer to Workshop Manual section 09-17 BACK TRIM REMOVAL / INSTALLATION.
