Subject: VARIABLE VALVE TIMING (VVT) NOISE WHEN STARTING ENGINE	Bulletin No: 01-010/11
	Last Issued: 02/23/2011

2003-08 Mazda6 (2.3L) vehicles

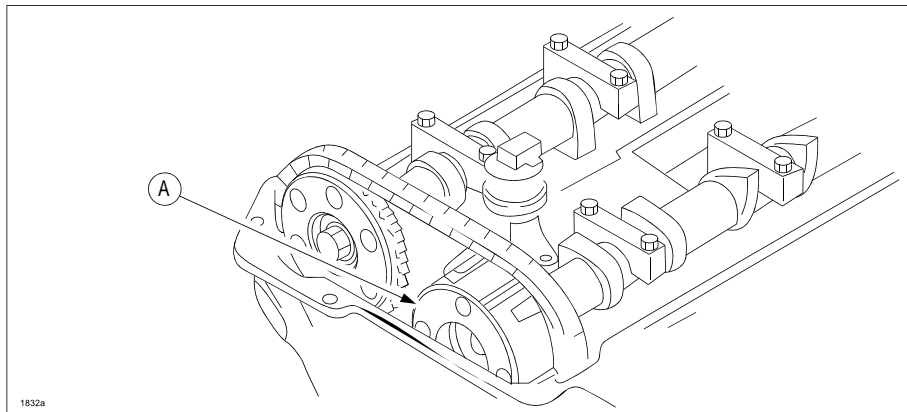
When the engine is first started, some vehicles may exhibit a loud ticking noise from the variable valve timing (VVT) (A). This is caused by the lock pin of the variable valve timing actuator not fully engaging or from a worn lock pin hole. Heat treatment has now been added around the hole of the variable valve timing rotor lock pin to prevent this from happening.

Customers having this concern should have their vehicle repaired using the following repair procedure.

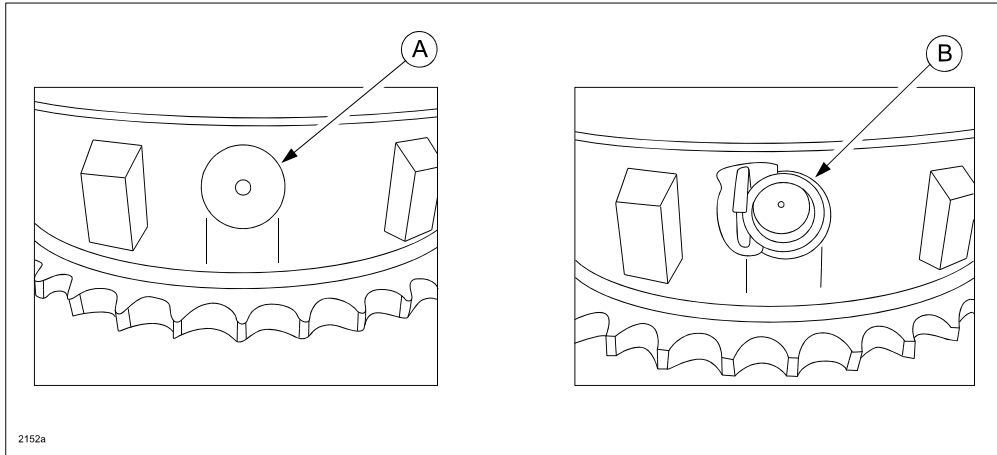
1. Verify customer concern.
2. Write down the customer's radio station presets.
3. After the engine cools down, disconnect the negative battery cable (to prevent DTCs from being stored).
4. Remove the cylinder head cover. Refer to MS3 online instruction.
5. For vehicles with turbo engines (L3T), inspect the variable valve timing actuator for damage around the stopper pin cap (A) or a missing stopper pin cap (B), spring and stopper.

- If no parts are damaged or missing, go to step 6.
 - If any parts are damaged or missing, go to step 10.
6. Turn the crankshaft clockwise so that the notches on the variable valve timing actuator can be checked.
 - A. If the notches are NOT aligned, go to the next step.
 - B. If the notches are aligned, there is no problem with the variable valve timing actuator and this information is not applicable. Refer to MS3 online instructions for troubleshooting.

10. Replace the variable valve timing actuator.

- If any parts are damaged or missing, remove the front cover to inspect the timing and oil pump chains and all related components for damage as a result of the loose parts. Replace components as necessary.
- If the loose parts cannot be located in the timing chain area, it will be necessary to remove the oil pan to remove them.

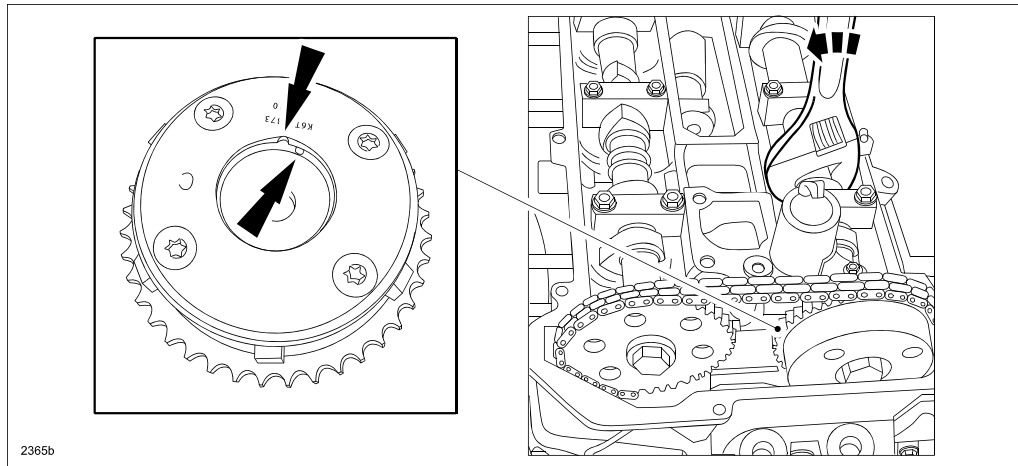
7. Turn the camshaft counterclockwise to align the notches on the variable valve timing actuator.

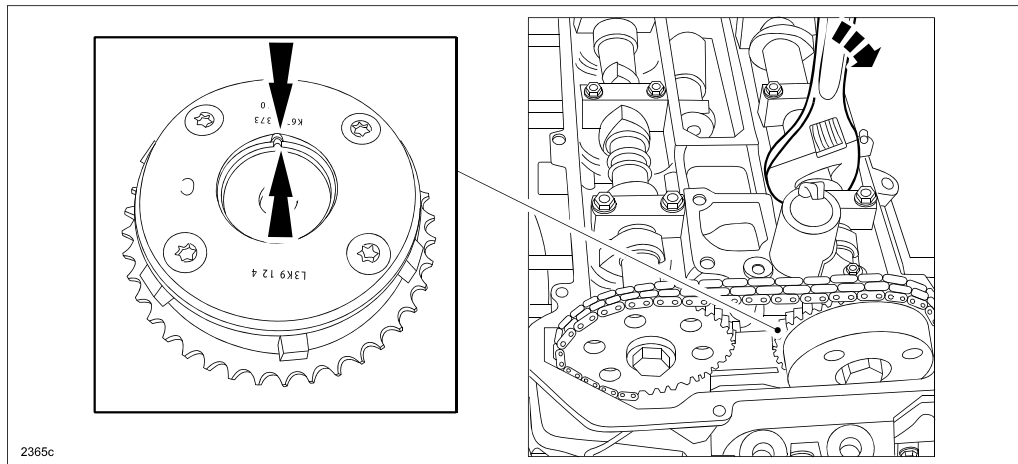
8. With the notches aligned, turn the camshaft clockwise 90 degrees.

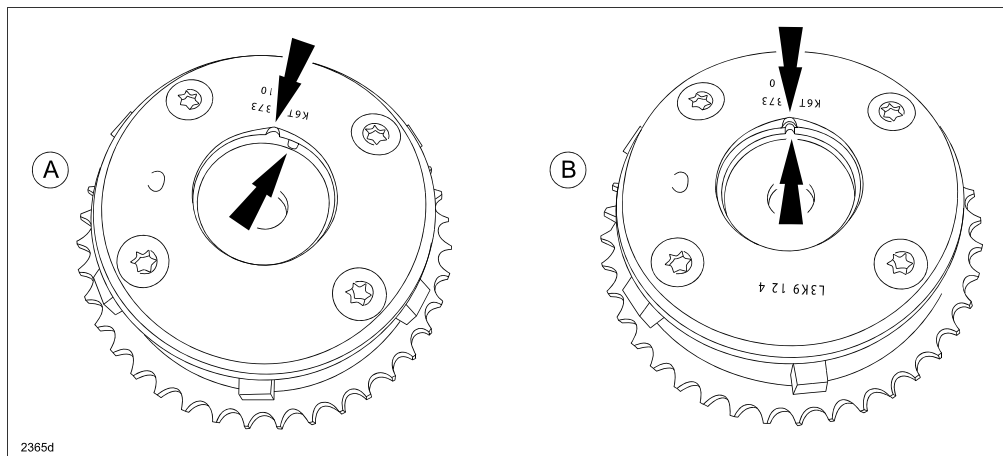
9. Check the notches again.

A. If the notches are NOT aligned, go to the next step.

B. If the notches are aligned, there is no problem with the variable valve timing actuator and this information is not applicable. Refer to MS3 online instruction.
