Service Bulletin

SHOCK ABSORBER REPLACEMENT GUIDELINES

Bulletin No: 02-004/11	Last Issued: 07/11/2011
© 2011 Mazda Motor of America, Inc.

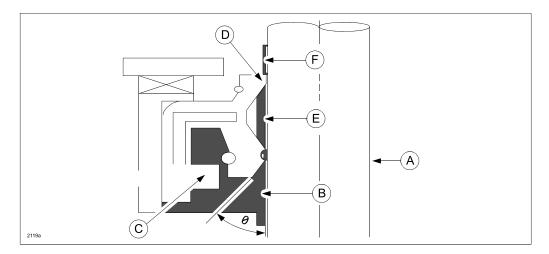
- A small amount of oil seeps outside through the dust lip during normal operation.
- The oil film thickness is uneven due to production variation of rod and seal.

When the rod (A) receives input from the road and extends upward, most of the oil (B) on the rod is scraped off by the main lip (C) and some remains inside the dust lip (D). When the rod extends further, then most of the remaining oil (E) on the rod is scraped off by the dust lip, and a small amount of oil seeps out (F).

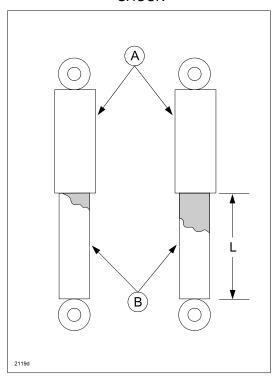
SHOCK

- Oil seepage comes out under the dust cover (A) and covers not more than 50% of the outer cylinder (B) length (L).
- The surface appears dirty due to oil and dust, but it is not wet with oil dripping / running down the sides.
- The damping function is still performing correctly.

Dealer action: Clean and dry the unit as much as possible. NO REPLACEMENT NECESSARY.

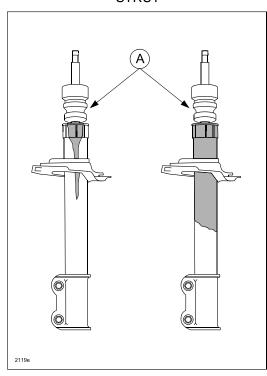
STRUT

- Oil leakage comes out below the bump cap (A) and runs down the sides past the spring seat.
- The surface appears wet with oil dripping / running down the sides.

Dealer action: REPLACE THE UNIT.

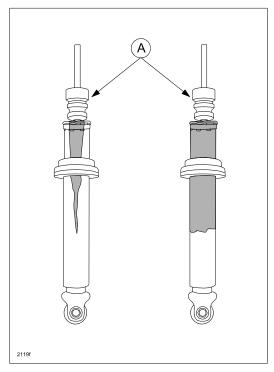
SHOCK ABSORBER WITH SPRING SEAT

- Oil leakage comes out below the bump cap (A) and runs down the sides past the spring seat.
- The surface appears wet with oil dripping / running down the sides.

Dealer action: REPLACE THE UNIT.

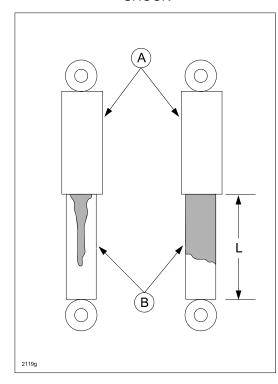
SHOCK

- Oil leakage comes out under the dust cover (A) and covers 50% or more of the outer cylinder (B) length (L).
- The surface appears wet with oil dripping / running down the sides.

Dealer action: REPLACE THE UNIT.
