Service Bulletin

Subject: Bulletin No: 02-007/09

MULTI MODEL - TPMS VALVE STEM BREAKS WHEN REMOVING AFTERMAR-KET VALVE STEM CAPS

Last Issued: 07/06/2009

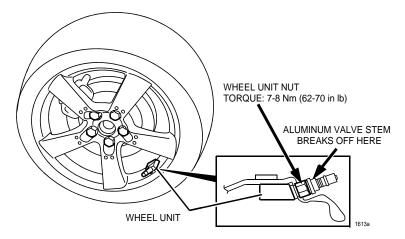
Some vehicles may experience the aluminum valve stem breaking off of the TPMS wheel unit when removing aftermarket valve stem caps during procedures such as routine checking of air pressure in tires.

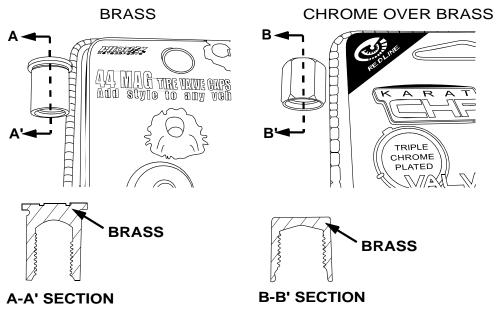
TYPICAL AFTERMARKET VALVE STEM CAPS

Some aftermarket valve stem caps are made of brass or have thread inserts that are made of brass. Examples of these types of aftermarket valve stem caps are shown. When brass and aluminum are together in such a condition as this, galvanic corrosion occurs between the aluminum valve stem of the TPMS wheel unit and the brass threads of the valve stem cap. This corrosion can cause them to fuse together, becoming difficult to

remove by hand. When more force is used to remove the valve stem cap, the aluminum valve stem of the TPMS wheel unit will break off and the TPMS wheel unit will be to be replaced.

This service bulletin can aid in informing customers of the damage that may be caused to the TPMS wheel units by installing these types of valve stem caps. Advise customers to use aluminum or plastic caps ONLY. Also, ensure that the caps they choose to install DO NOT have a brass thread insert.
