Subject: WATER DROPS TRAPPED UNDER HIGH MOUNT STOP LIGHT LENS	Bulletin No: 09-004/09
	Last Issued: 1/22/2009

2006-2009 MX-5

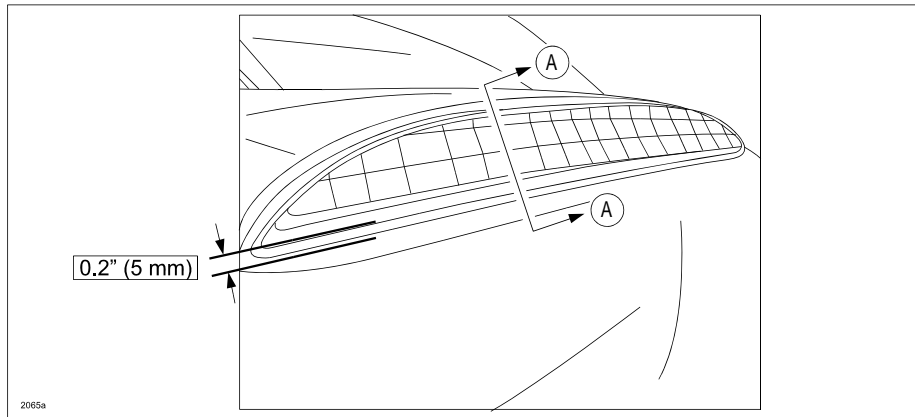
Some customers may complain of water drops trapped under the lower edge of the high mount stop light lens. If water drops are within 0.2" (5 mm) from the lower edge of the high mount stop light, water entry is not a concern. DO NOT replace the light due to this symptom.
