Subject: AM RADIO - POOR RECEPTION	Bulletin No: 09-010/07
	Last Issued: 3/21/2007

2006-2007 MX-5 vehicles with VINs lower than JM1 NC**** ** 130963 (produced before November 8, 2006)

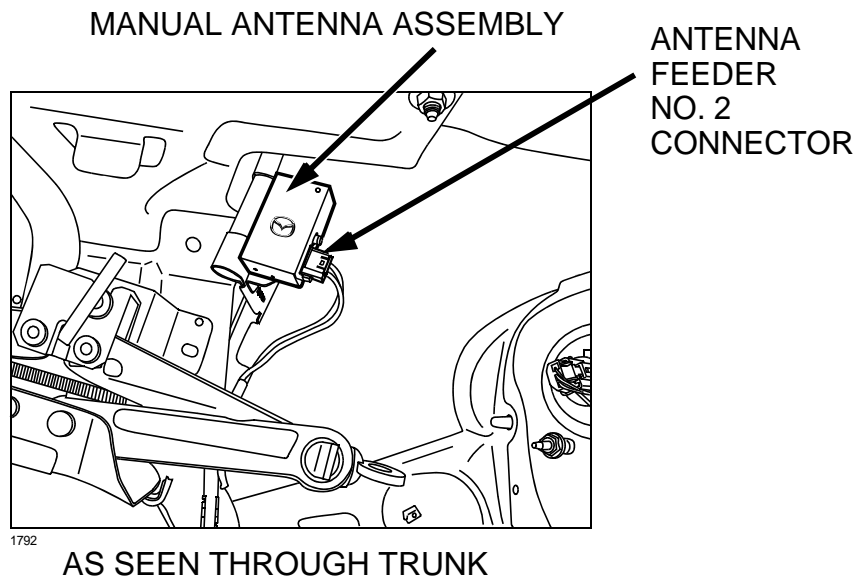
Some vehicles may experience poor reception or excessive static when listening to AM radio stations. This condition may be the result of static electricity damaging the AM amplifier that is located at the base of the antenna.

1. Verify customer concern.
2. Replace the manual antenna with a modified one. Refer to Workshop Manual section 09-20 MANUAL ANTENNA REMOVAL / INSTALLATION.
