Subject: ACCESSORY POWER PLUG / CHARGER STUCK IN ACCESSORY SOCKET	Bulletin No: 09-013/10
	Last Issued: 04/08/2010

2009-2010 Mazda6 vehicles (produced before December 21, 2009)

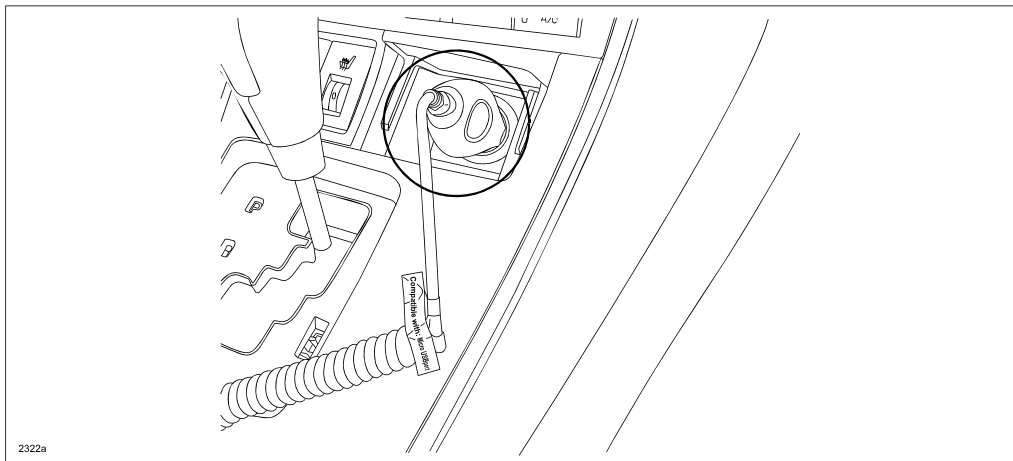
Some aftermarket power plug / chargers may become stuck in the accessory socket. This is caused by the negative spring contacts of the power plug / charger locking into the slots of the accessory socket. A modified accessory socket is now available to prevent this from happening.

Customers having this concern should have their vehicle repaired using the following repair procedure.
