Subject: SOFT TOP LATCH AND/OR COVER RATTLING	Bulletin No: 09-021/08
	Last Issued: 7/30/2008

2006-2007 MX-5 with VINs lower than JM1 NC**** ** 134259 (built before January 15, 2007)

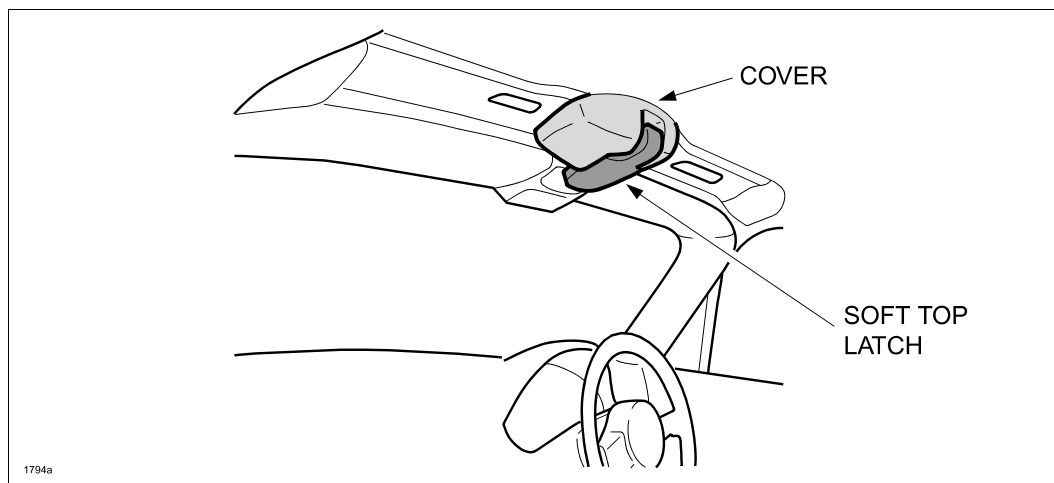
Some vehicles may exhibit a rattling noise from the soft top latch cover caused by looseness in the soft top latch cover.

As a mass production change to prevent the noise, a pad has been attached to the location where the soft top cover is making the noise. Customers having this concern should have their vehicle repaired using the following repair procedure.
