# Service Bulletin Mazda North American Operations

Subject: **Bulletin No:** 09-028/07 SOFT TOP LATCH AND/OR COVER RATTLING Last Issued: 7/18/2007

2006-2007 MX-5 with VINs lower than JM1 NC\*\*\*\* \*\* 134259 (built before January 15, 2007)

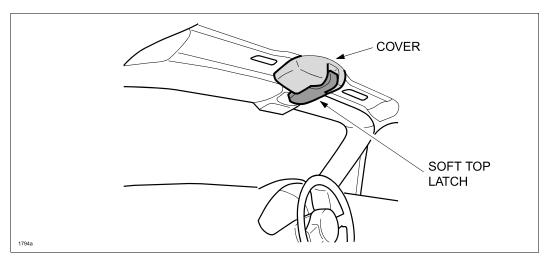
Some vehicles may exhibit a rattling noise from the soft top latch cover caused by looseness in the soft top latch cover.

As a mass production change to prevent the noise, a pad has been attached to the location where the soft top cover is making the noise. Customers having this concern should have their vehicle repaired using the following repair procedure.
