Service Bulletin

Subject: Bulletin No: 09-032/09

DASHBOARD UPPER SURFACE POOR APPEARANCE

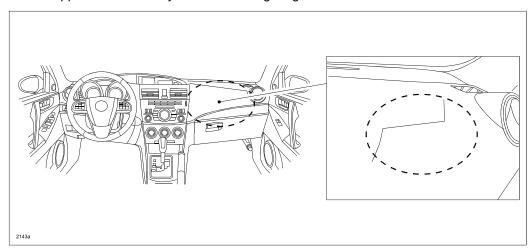
Some customers may complain of a poor appearance or lines on upper surface of dashboard on the passenger side. Please explain to the customer that the appearance is normal and does not require repair. The lines are internal and are part of the air bag deployment system. This is normal and does not affect vehicle performance.

NOTE: The line appearance will vary with different lighting conditions.

The airbag cover is made of a thin plastic with a tear line incorporated internally for deployment. The appearance concern does not affect vehicle performance and does not require repair.
