# Service Bulletin

Subject: WATER ACCUMULATION IN FOOTWELL / PLUGGED SOFT TOP DRAINS	Bulletin No:	09-046/10
	Last Issued:	10/15/2010

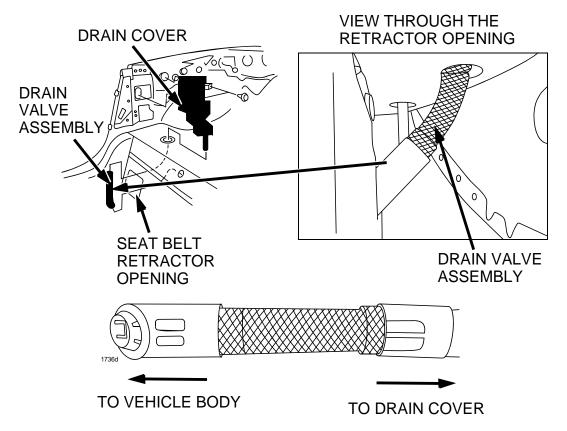
Some vehicles equipped with the folding soft top may experience water accumulation in the foot wells due to the soft top drains becoming clogged with leaves and other debris.

- TYPE A VEHICLES: Proceed to next step.
- TYPE B VEHICLES: Proceed to "TYPE B VEHICLES" under DRAIN VALVE REPLACEMENT.
- 4. Using seat belt retractor holes for access, remove the drain valve assemblies.
