2006-2013 MX-5, 2010-2013 Mazda3 AIRBAG LIGHT ON WITH DTC B1013 AND/OR B2290

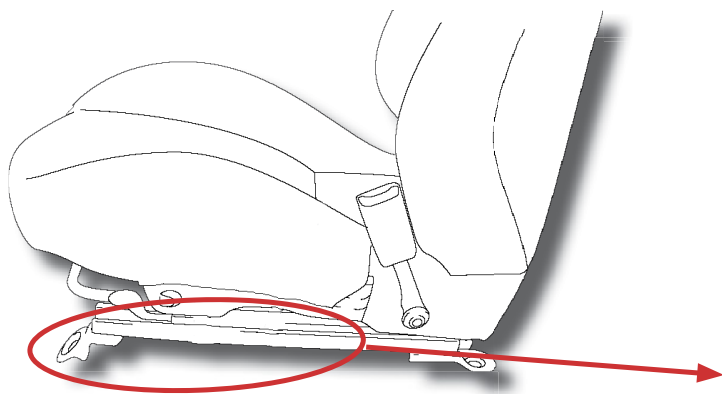
Some customers may experience an airbag warning light on with DTC B1013 (seat weight sensor calibration error) and/or B2290 (passenger sensing system malfunction) stored in memory. This may be caused by foreign objects in the passenger seat rail system.

Remove the foreign object, then perform seat weight sensor calibration to resolve the concern.

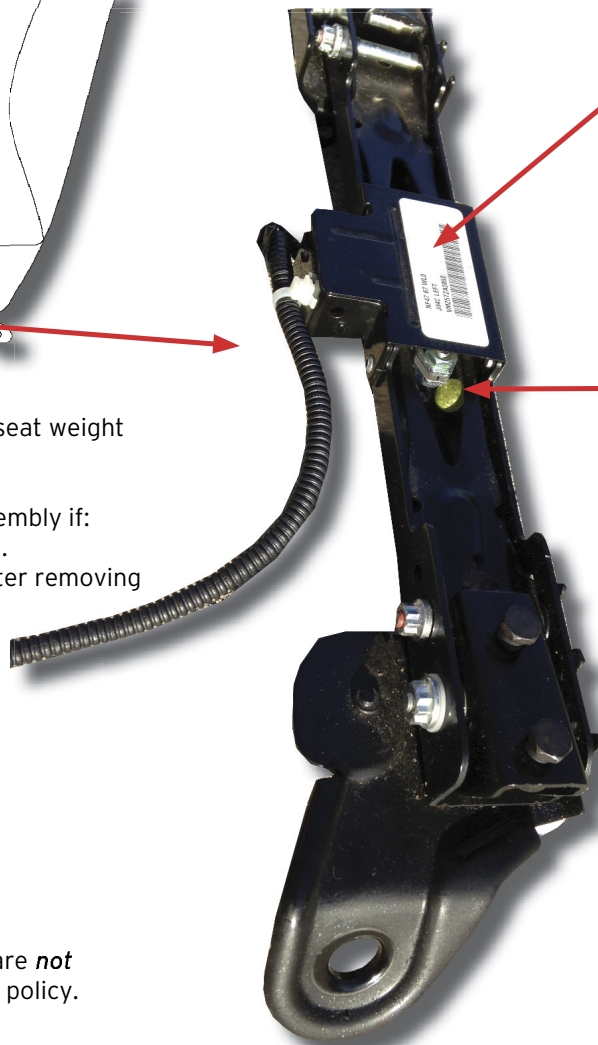
Seat weight sensor.

Foreign object jammed between the seat rail and seat weight sensor.

Note: Replace the passenger seat rail assembly if:

- The foreign object cannot be removed.
- Seat weight sensor calibration fails after removing the foreign object.
