# Service Information

Category <b>T</b>	<b>Technical</b>	Ref. No. <b>E006/09A</b>	Page 1 of 4
Coverage <input type="checkbox"/> Distributor only <input checked="" type="checkbox"/> Please inform your dealers		Date Issued <b>January 27, 2009</b>	
Please convey this information to your <input type="checkbox"/> Director <input checked="" type="checkbox"/> General Manager <input checked="" type="checkbox"/> Warranty Dept. <input checked="" type="checkbox"/> Parts Dept. <input checked="" type="checkbox"/> Training Dept. <input checked="" type="checkbox"/> Field Rep.		Date Revised <b>January 8, 2014</b>	
Applicable Model  <b>All Models</b>		Applicable Countries or Specifications  Worldwide

## Subject: Foggy Lens (Condensation) of Headlight, Rear Combination Light and Other Lamps

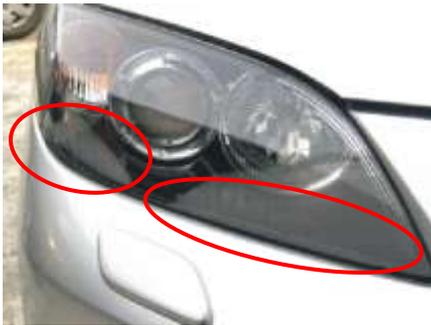
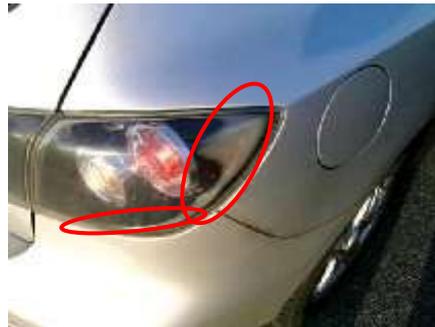
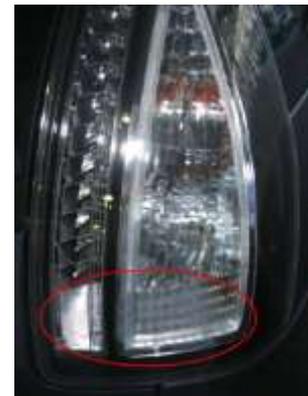
<BK / CR>

**Example of Foggy Lens: Miniscule water droplets stick the lens and lens gets whitish**

This symptom (fog) appears only on a certain location of the lamp unit in which the air is stagnant. Mostly this appears in the corner and narrow space. The location where the bulbs are fitted is of high volume and also the air is circulating, therefore the fog is **unlikely** to appear.

Temporary Measure: Remove the bulb and socket, and send air using a drier through the hole.
