# Service Information

Category <b>S</b>	<b>Repair Guidance</b>	Ref. No. R080/16	Page 1 of 10
Coverage <input type="checkbox"/> Distributor only <input checked="" type="checkbox"/> Please inform your dealers		Date Issued September 30, 2016	
Please convey this information to your <input type="checkbox"/> Director <input checked="" type="checkbox"/> General Manager <input checked="" type="checkbox"/> Warranty Dept. <input checked="" type="checkbox"/> Parts Dept. <input checked="" type="checkbox"/> Training Dept. <input checked="" type="checkbox"/> Field Rep.		Date Revised	
Applicable Model MX-5 (ND) without Inner Cloth for Convertible Top	Applicable Countries and/or Vehicle Specifications North America and Europe

## Subject: Convertible Top Tension Band(s) detached from Header Panel and hanging down

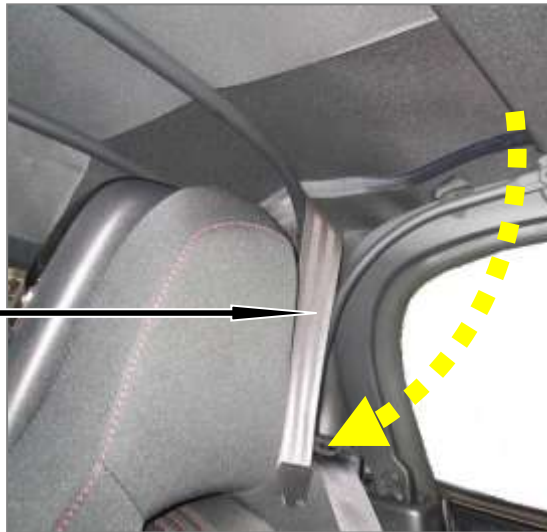
**Tension Band** is hanging down from convertible top.

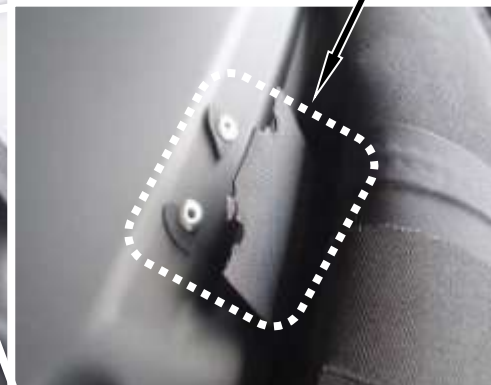
**Plastic Plate** of tension band is broken at riveting to header panel.

The plastic plate of the tension band is broken due to insufficient strength.

1. Remove the broken plastic plate (A) from the tension band (B).
2. Push two holes in the tension band and the header panel (C) respectively at the specified positions.
3. Fix the tension band to the header panel with two rivets and washers (D).
