Service Information

Category T	Repair Guidance		Ref. No. R088/17	Page 1 of 15
Coverage ☐ Distributor only ■ Please inform your dealers			Date Issued December 28, 2017	
Please convey this information to your ☐ Director ☐ General Manager ☐ Warranty Dept. ☐ Parts Dept. ☐ Training Dept. ☐ Field Rep.		· ·	Date Revised	
Applicable Model Applicable Countries and/or Vehicle Specifications		3		
MX-5 (ND)		Worldwide

Subject: Engine will not start (Engine can start if touching Push Button Start using Backside of Key)

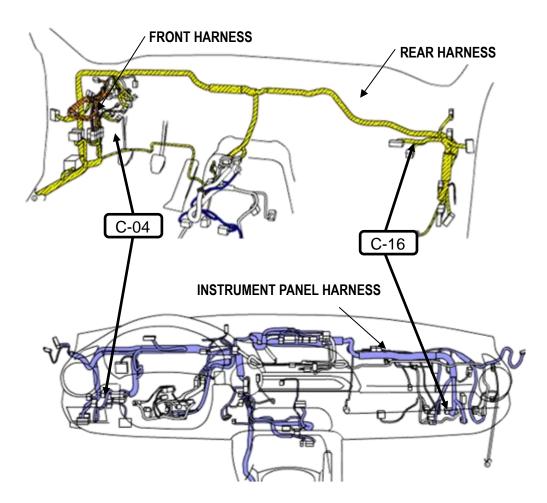
Location of Connectors (for L.H.D.)

Condense water from windshield inner surface flows down in between the windshield and the dashboard and causes corrosion of the terminals at connectors C-16 and/or C-04.

Shield plates have been attached to the dashboard upper to prevent water from dropping onto the C-16 and C-04 connectors.

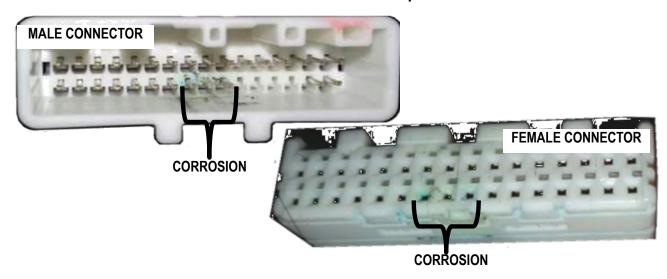
<Corroded Terminals Sample>

3. Inspect terminals of the C-16 connector for any corrosion.

If any terminal(s) is corroded, cut all the affected wires and connect them using a short connector from the repair kit. Go to step 4.

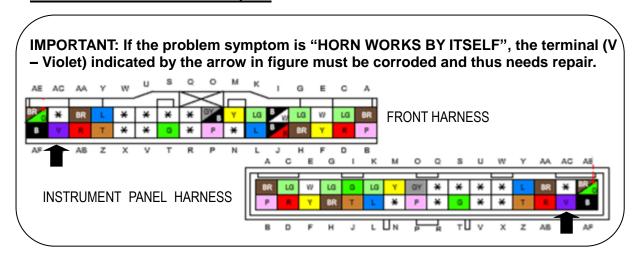
- 10. Inspect terminals of the C-04 connector for any sign of corrosion.
 - If any terminal(s) is corroded, cut all the affected wires and connect them using a short connector. Go to the step 11.

- ► If no terminal is corroded, apply grease to the C-04 connector. Go to the step 12.
- 11. Cut and connect wires with the corroded terminal using the same procedure of step 4 for the C-16 connector.
- 12. Apply grease to the C-04 connector using the same procedure of step 5 for the C-16 connector.
- 13. Install the C-04 connector in the reverse order of removal.
- 14. Attach the urethane pad (in Repair Kit) (A) over the short connector (B).
