# Technical Service Bulletin

<b>Subject:</b> <b>AIR CONDITIONER DOES NOT BLOW COLD AIR DUE TO CRACKED COOLER PIPE (HI) A (REFRIGERANT LEAK)</b>	<b>Bulletin No.:</b> 07-004/18
	<b>Last Issued:</b> 08/01/2018

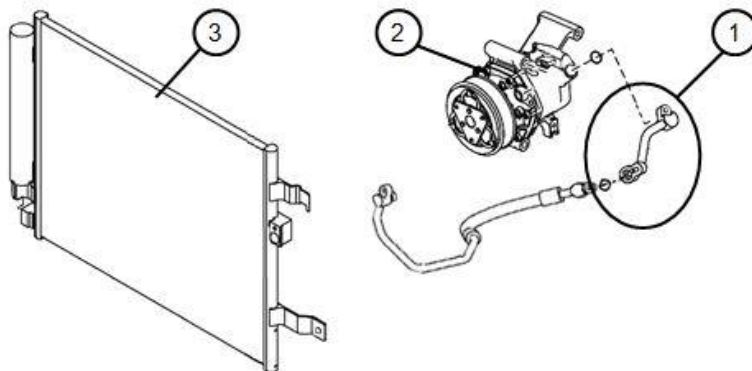
Some vehicles may experience that the A/C does not blow cold air (blows warm air) due to a refrigerant leak. This is caused by a crack in the cooler pipe (HI) A (1) due to engine vibration. To correct this issue, the material and thickness of the cooler pipe (HI) A has been changed to increase durability.

(1)	Cooler pipe (HI) A
(2)	A/C compressor

1. Verify customer concern.
2. Inspect the cooler pipe (HI) A.
  - If the cooler pipe (HI) A is cracked, replace the cooler pipe (HI) A with a modified one according to the instructions on MGSS (REFRIGERANT LINE REMOVAL/INSTALLATION).
  - If the cooler pipe (HI) A is not cracked, this TSB is not applicable. Refer to troubleshooting procedure on MGSS (NO COOL AIR [CLIMATE CONTROL SYSTEM]).
3. Verify repair.

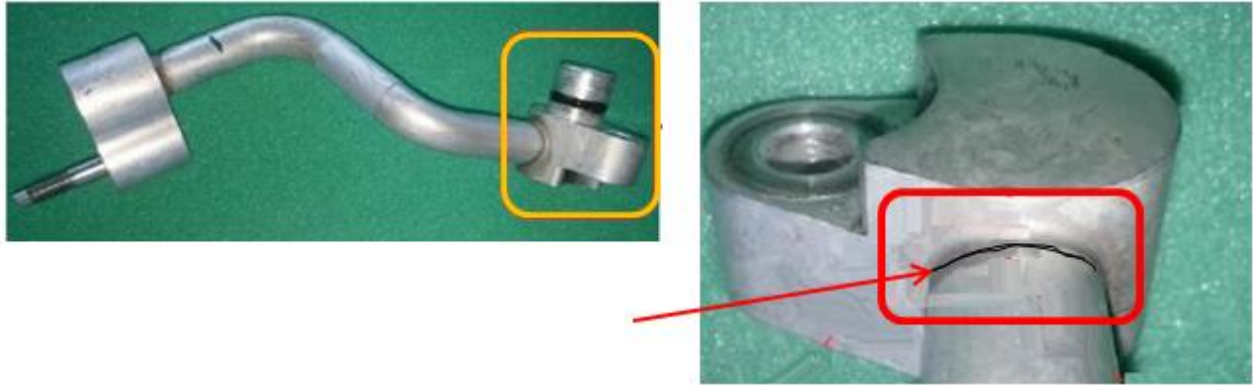
(3) Condenser

Location of cracking
