# Service Information

Category <b>S</b>	<b>Repair Guidance</b>	Ref. No. R079/08A	Page 1 of 4
Coverage <input type="checkbox"/> Distributor only <input checked="" type="checkbox"/> Please inform your dealers		Date Issued September 29, 2008	
Please convey this information to your <input checked="" type="checkbox"/> Warranty Dept. <input checked="" type="checkbox"/> Parts Dept. <input type="checkbox"/> Director <input checked="" type="checkbox"/> General Manager <input type="checkbox"/> Training Dept. <input checked="" type="checkbox"/> Field Rep.		Date Revised January 27, 2012	
Applicable Model MX-5 (NC) with Retractable Hardtop		Applicable Countries or Specifications Worldwide

## Subject: Rattling Noise from Windshield Header and Roof Panel While Driving (RHT Only)

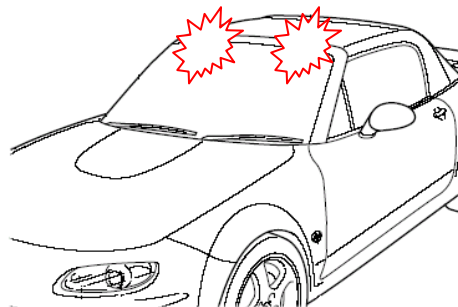
On some vehicles the windshield header and roof panel are causing a rattling noise while driving.

When you encounter a customer complaint on this concern, tighten the top lock adjustment nut by one turn according to the Workshop Manual "POWER RETRACTABLE HARDTOP ADJUSTMENT".
