# **Service Information**

Category S	Repair Guidance		Ref. No. R086/10 <mark>A</mark>	Page 1 of 3
Coverage □ Distributor only ■ Please inform your dealers			Date Issued October 29, 2010	
Please convey this information to your □ Director □ General Manage   Warranty Dept. □ Parts Dept. □ Training Dept. □ Field Rep.		8	Date Revised December 8, 2011	
Applicable Model		Applicable Countries or Specifications		
MX-5/Miata (NC)		Worldwide

# Subject: Poor Seat Belt Retraction

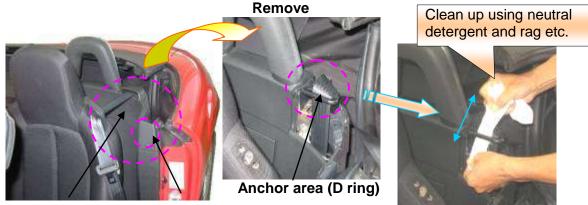
Anchor cover

Fastener

\*Cleaning of anchor area: Remove the fastener and the anchor cover to remove smudges on the seat belt anchor area (D ring).

Confirm the retraction performance after cleaning.

If now within specification: Make sure that the customer takes care of the interior maintenance such like seat belt (removal of smudges) on a regular basis. If not within specification: Go to the next step.

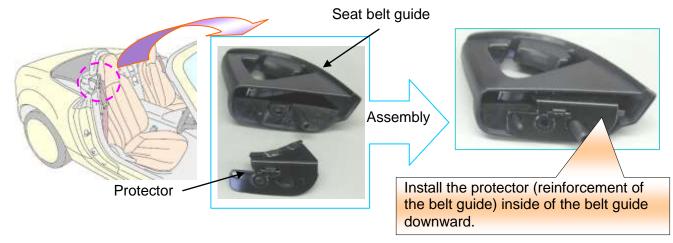
(1) Remove the seat belt guide (combined with the protector).Loosen the attachment screw and remove the seat belt guide & protector.

Note: \*The shape of the belt guide (Service parts) has been changed as illustration.

(2) Assembly new seat belt guide & new protector, then install it using original screw.

- (3) Confirm the performance of seat belt retraction and if it's not improved, clean up the seat belt & anchor area again.
- (4) Make sure cleanness and installation of each part is kept in a good condition.
