### **Service Information**

Category <b>G</b>	Repair Guidance		Ref. No. R078/17A	Page 1 of 4
Coverage  ☐ Distributor only ■ Please inform your dealers			Date Issued November 27, 2017	
Please convey this information to your ☐ Director ☐ General M ☐ Warranty Dept. ☐ Parts Dept. ☐ Training Dept. ☐ Field Rep		•	Date Revised January 19, 2018	
Applicable Model		Applicable Countries and/or Vehicle Specifications		
Mazda2 (DJ), CX-3 (DK) and MX-5 (ND) with i-ELOOP		Europe

# Subject: i-ELOOP and Charging System Warning Light illumination, i-STOP Warning Light (Amber) flashing and DTC P1794:00 stored

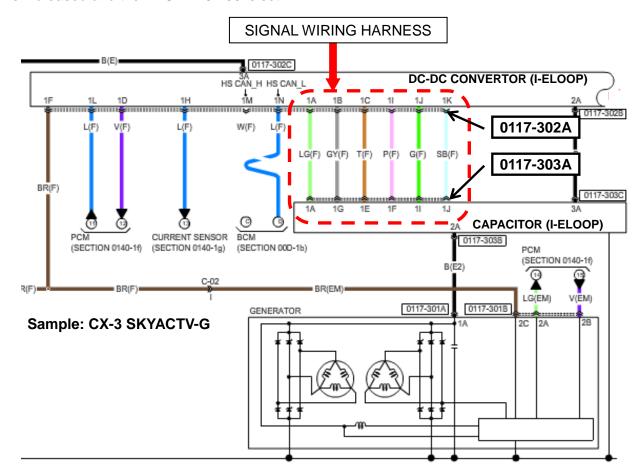
An oxide film may be formed on terminals in the connectors (0117-302A and 303A) for the signal wiring harness between the DC-DC convertor and the capacitor. Due to this, terminal resistance is increased and the DTC P1794:00 is set.

The software of DC-DC convertor has been/will be changed to increase the electrical current for signal wiring, preventing occurrence of oxide film.
