Subject: ABNORMAL HEATER PERFORMANCE AT IDLE	Bulletin No: 07-001/06
	Last Issued: 3/13/2006

2006 MX-5 vehicles with VINs lower than JM1 NC**** 60 111258 (produced before December 22, 2005)

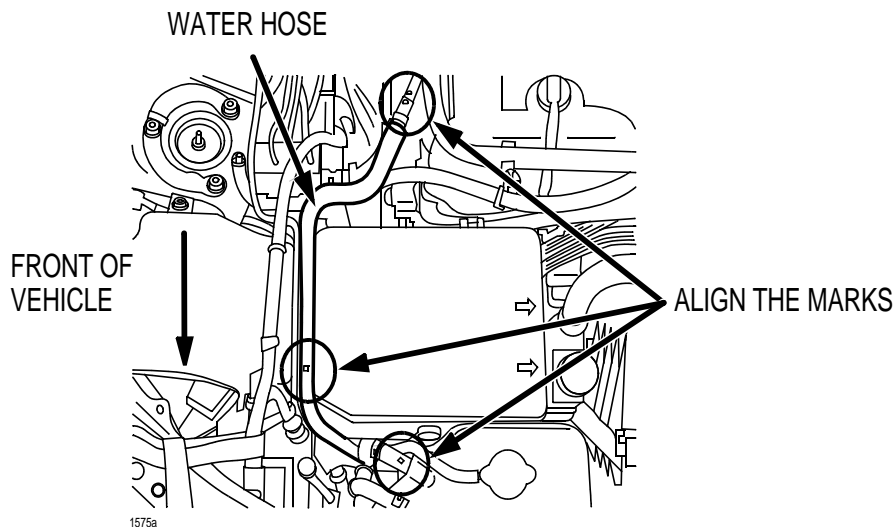
Some customers that park their vehicle on a decline or brake hard during cold engine conditions may experience abnormal heater performance at idle. This condition can be the result of air moving up from the radiator sub-tank through the thermostat housing and becoming trapped in the heater core and/or its supply lines.

To prevent this condition from occurring, the shape of the hose between the radiator sub-tank and the thermostat has been changed. Customers having this concern should have their vehicle repaired using the following repair procedure.

- If the engine is very hot and the water hose is compressed, be careful when removing the cooling system cap. Wrap a thick cloth around it and slowly turn it counterclockwise to the first stop. Step back while the pressure escapes before proceeding with any repair.
1. Verify customer concern.
 2. Remove the water hose.
 3. Align each mark and fit a modified water hose.
